# **Investigation**Information release

# Serious injury

Event: Serious injury at an open cut coal mine

Location: Bulga Surface Operations, Singleton NSW

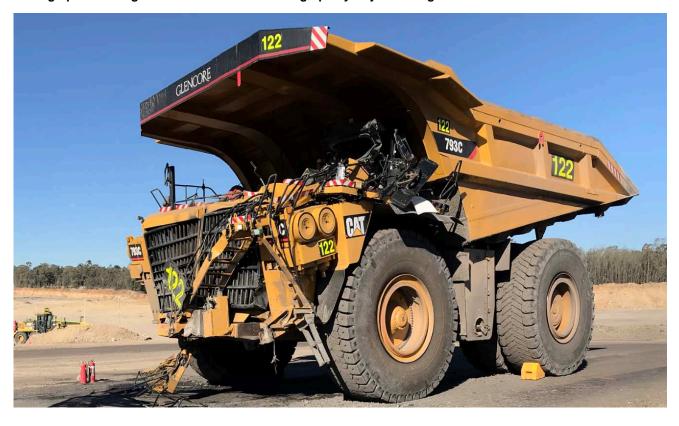
Photograph 1: Damaged nose of haul truck. Photograph by Major Investigation Unit.

The worker failed to stop, which caused a nose-to-rear collision with the second unladen haul truck. The front of the worker's haul truck impacted with the rear edge of the tray of the second truck, crushing the operator's cabin and trapping the worker inside.

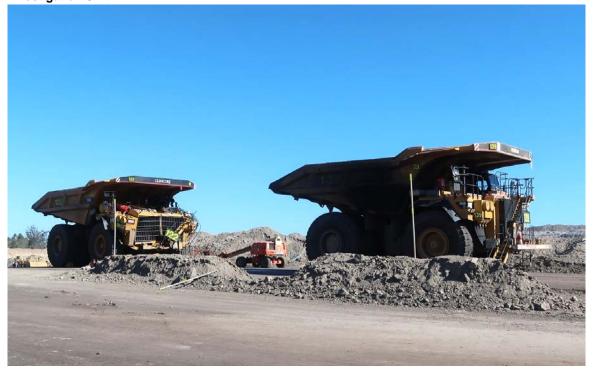
Photograph 2: Nose-to-tail collision of two dump truck showing height of truck tray and cabin. Photograph by Major Investigation Unit.

Preliminary enquiries indicate that fatigue may be a causal factor.

Principal hazard management plans must have control measures for roads and other vehicle operating areas. When developing control measures ensure all potential collision situations involving mobile plant interaction are identified. Consider the hierarchy of controls; including engineering controls such as mine road design and construction, proximity detection and collision avoidance systems, identification lights on mobile plant and mobile plant monitoring systems.
