2015.5869 R001A

7 April 2016

## MOUNT GAMBIER ROUNDHOUSE – ENGINEERS ASSESSMENT REPORT

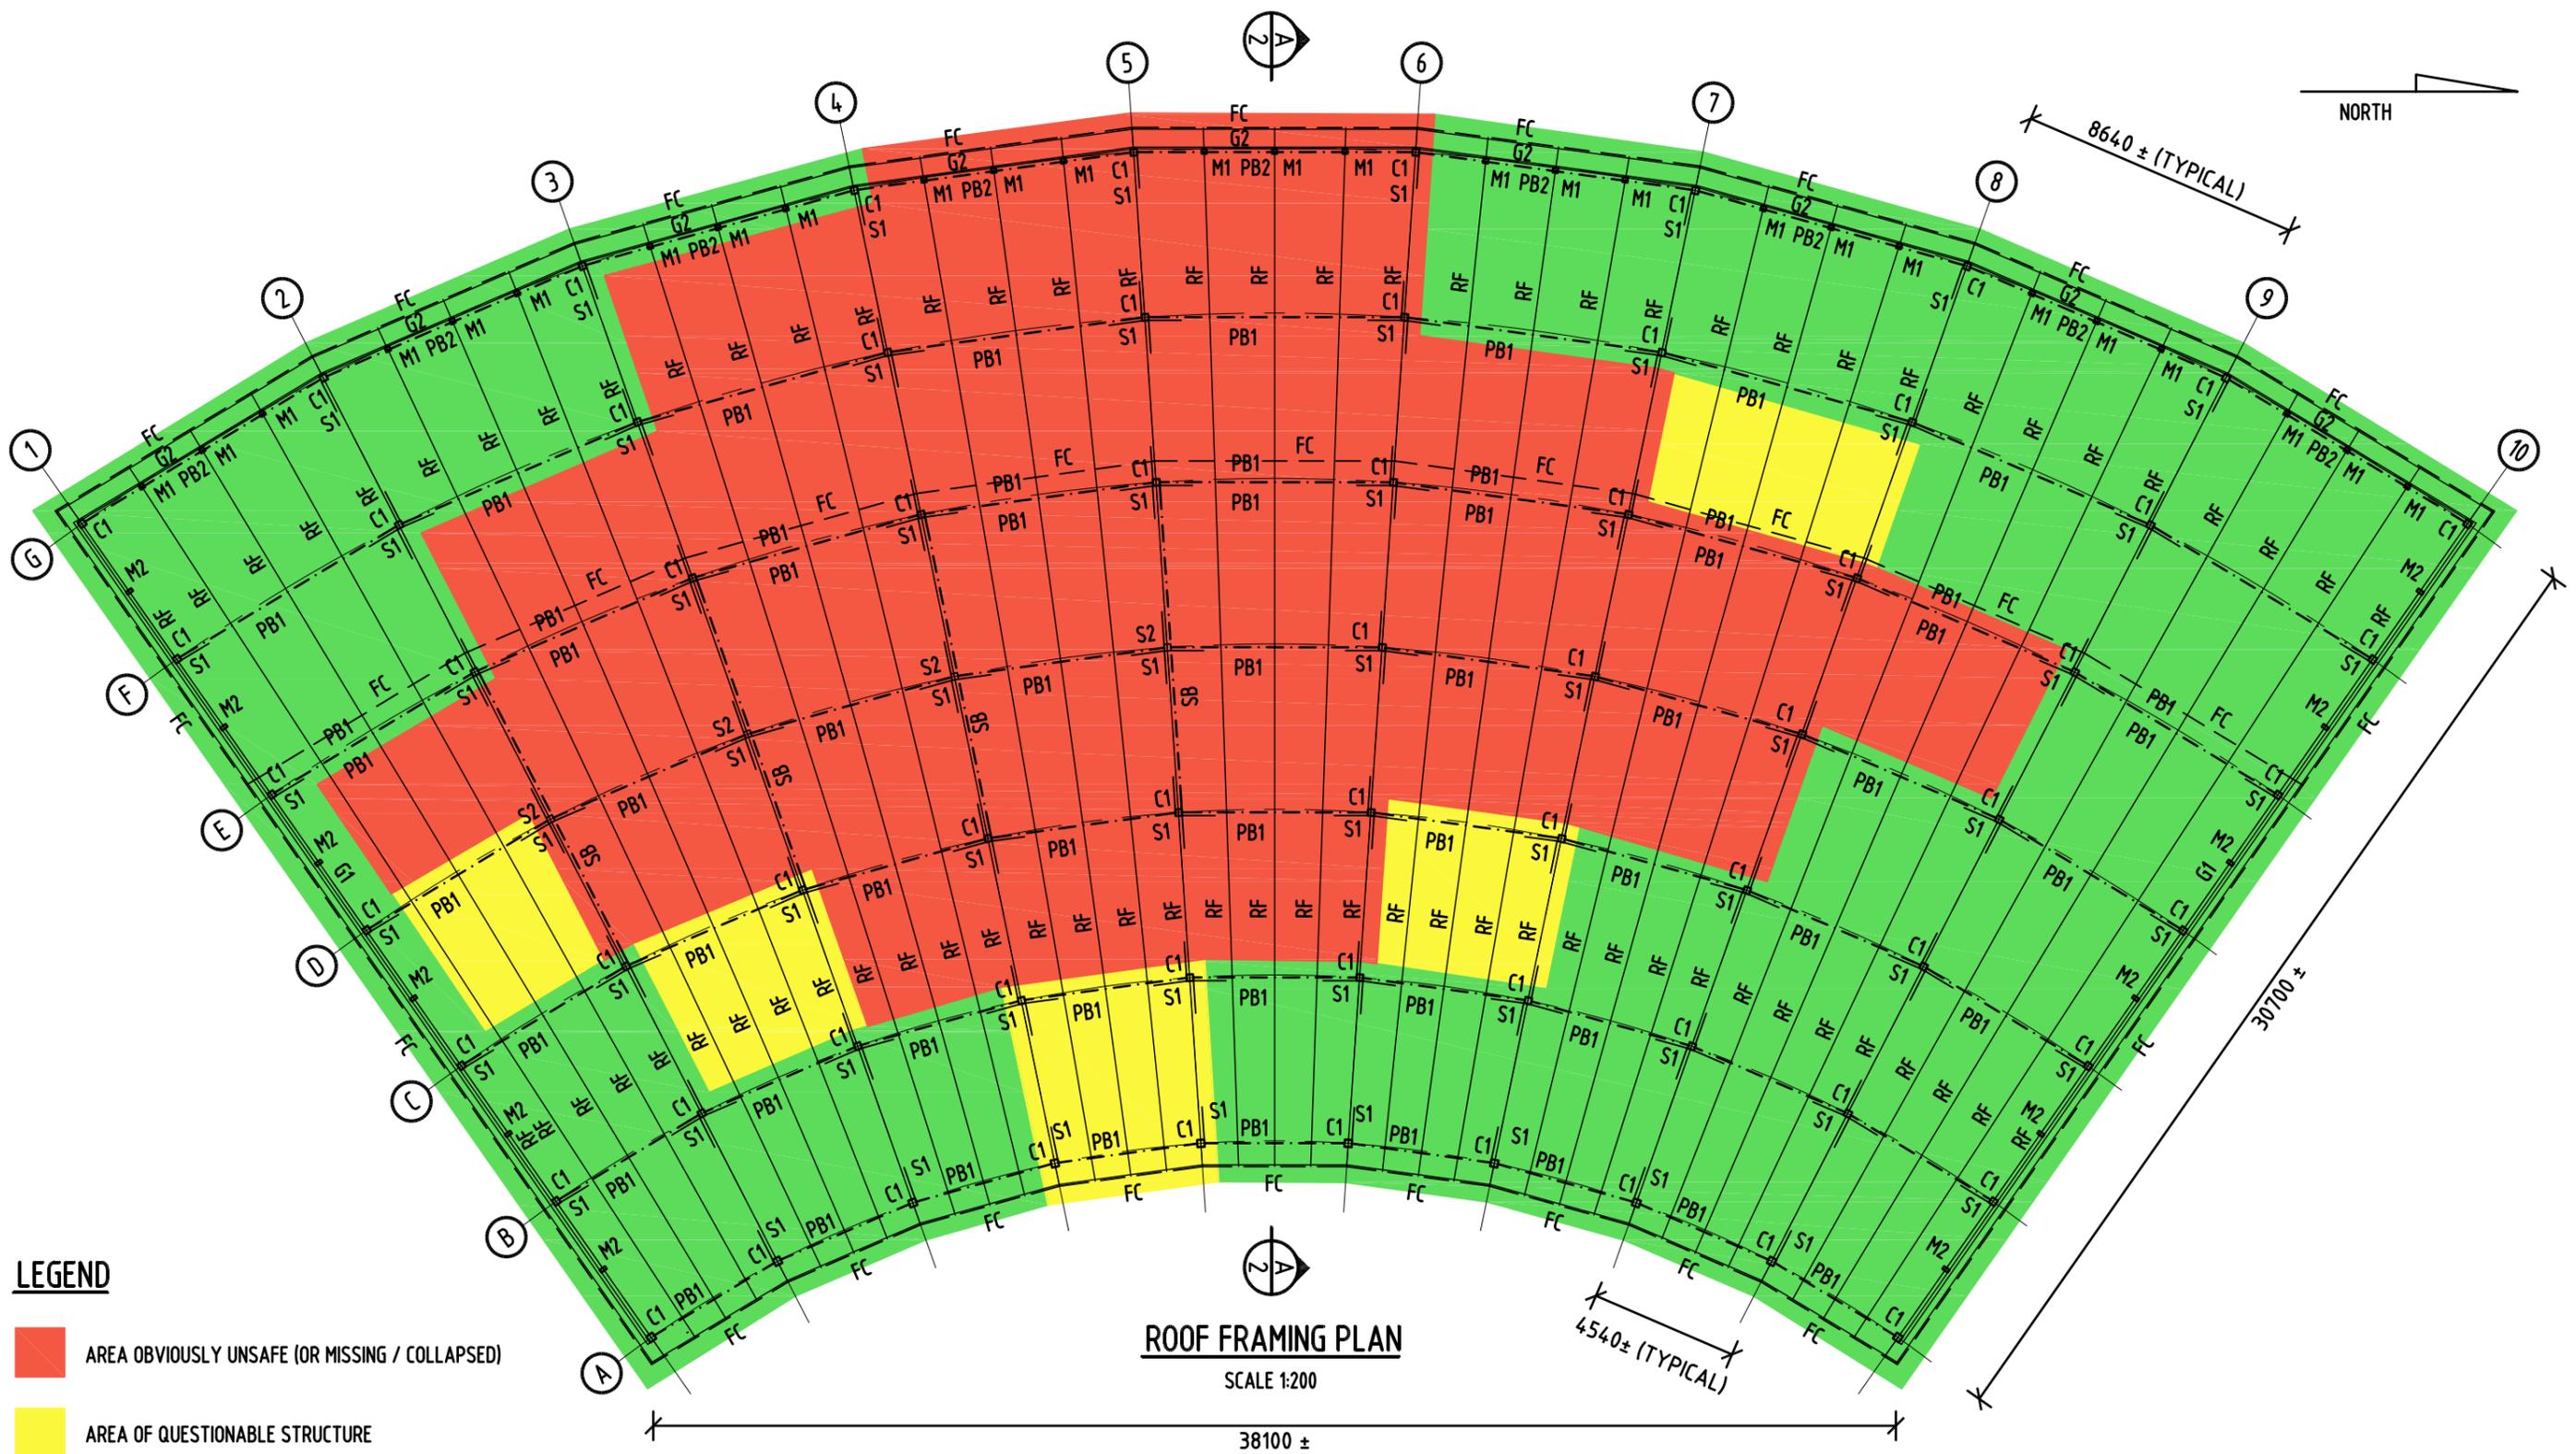
**ROOF FRAMING PLAN**

In February and March 2016, Gene Lassaline of Tonkin Consulting visited the site. We measured the existing building and developed the attached Plan and Section drawings of the Roundhouse. We have assessed which parts of the roof framing appear to still be structurally sound, which sections of the roof structure are questionable (without further up close investigation) and which parts are obviously unsafe / or previously collapsed /missing. (If all or some part of the roof framing members within a section bounded by 4 grid lines are considered as structurally unsound, we have labelled this section of the roof as Unsafe.) The results of this assessment have been marked on our Plan drawing.

As indicated on our Plan drawing, over half of the roof framing area has been damaged by the fire, with only the perimeter sections of the roof being unaffected. The majority of the heavy timber columns appear to generally be in sound condition, apart from localised fire damage to parts of some columns and previous railway work damage to others,
