SAFETY ALERT

SA Power Networks (SAPN) cable stay destroyed

May 2016

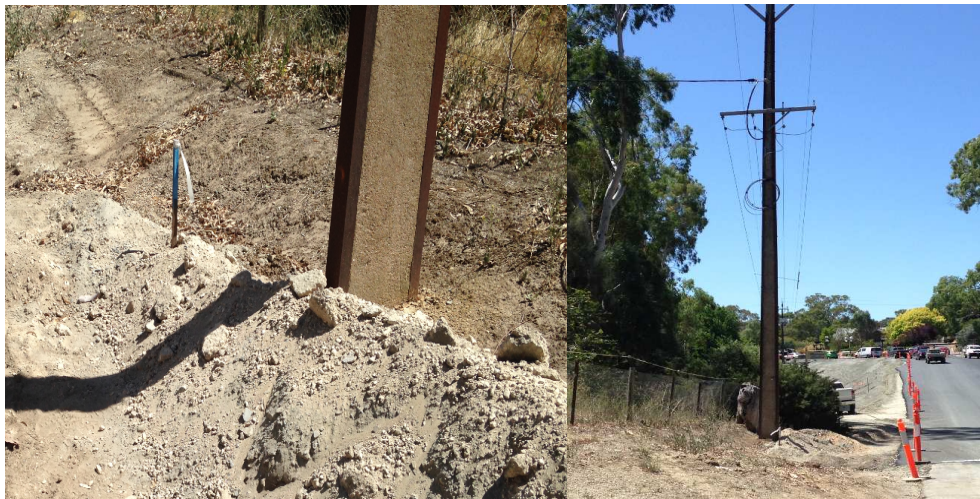
A machine operator was working on a project during night works when, to avoid hitting a conduit, he edged the machine forward and made contact with what he thought was a survey peg. However, it was actually a stobie pole stay which then recoiled and came into contact with the overhead powerlines.

This resulted in a power outage to the immediate area.

- Contractor to ensure all staff including new personnel are aware of site conditions and hazards.
- Light towers to be operational in accordance with SWMS, prior to nightfall.
- Stobie pole and cable stay locations are marked to ensure they are visible particularly if working near them at night.
- Discussion of the incident at the next start up and toolbox meeting.
- Identify and risk assess the hazards of a site when you arrive at a site.
- Ensure contractors understand and use their SWMS.
- Discuss and highlight site specific hazards at toolbox meetings.
