Safety Alert

Mobile Elevating Work Platforms (MEWP)

Basket attachment to Main Boom

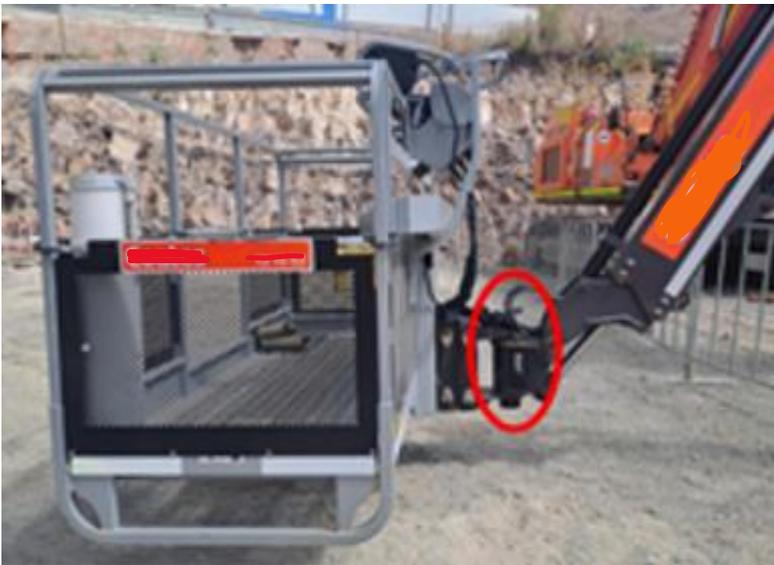
Bolts on the main knuckle of the MEWP that joins the basket to the Main Boom were found to be loose and not aligned as per the painted torque marks. One of the eight bolts was finger tight only and able to be removed by hand.

- All MEWPs on the project (6 in total) were tagged-out.
- Hire company called to site to discuss findings.
- Full inspection of all MEWPS by qualified mechanic.
- Confirmation of OEMs required torque for the bolts requested.
- Review of events that took place Pre delivery to site.

- Check bolt torque on all MEWPs currently onsite.
- MEWP plant onboarding & maintenance checks to include inspections of bolts.
