Vegetation Management – Update

Fact Sheet - Update

River Road

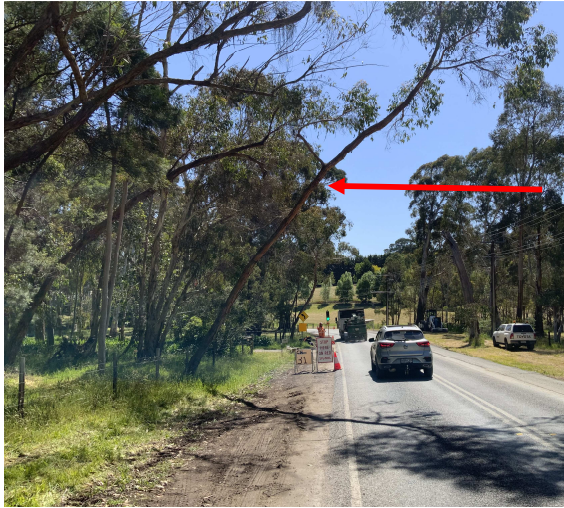
Example of a tree protruding into vegetation clearance envelope that must be removed

Trees being removed generally have a larger portion of the trunk encroaching into the clearance envelope that cannot be suitably pruned without impacting the health and structural stability of the tree.

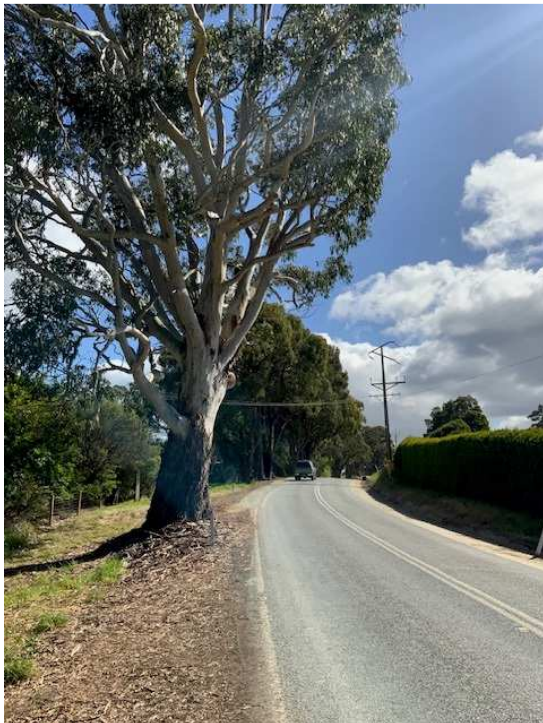
Example of large tree being retained

These trees will not be impacted as it has been possible to achieve the height clearance required for the vegetation clearance envelope, through pruning activities, without comprising the long-term health of the tree.
