ROAD MANAGEMENT PLAN
EDITION 2
(SHORT TO MEDIUM TERM)

MAIN ROAD (RN6452)
(Belair Road to Shepherds Hill Road)
SHEPHERDS HILL ROAD (RN6467)
(Main Road to Seymour Street)

February 2015

Transport Services Division
Document # 6923461

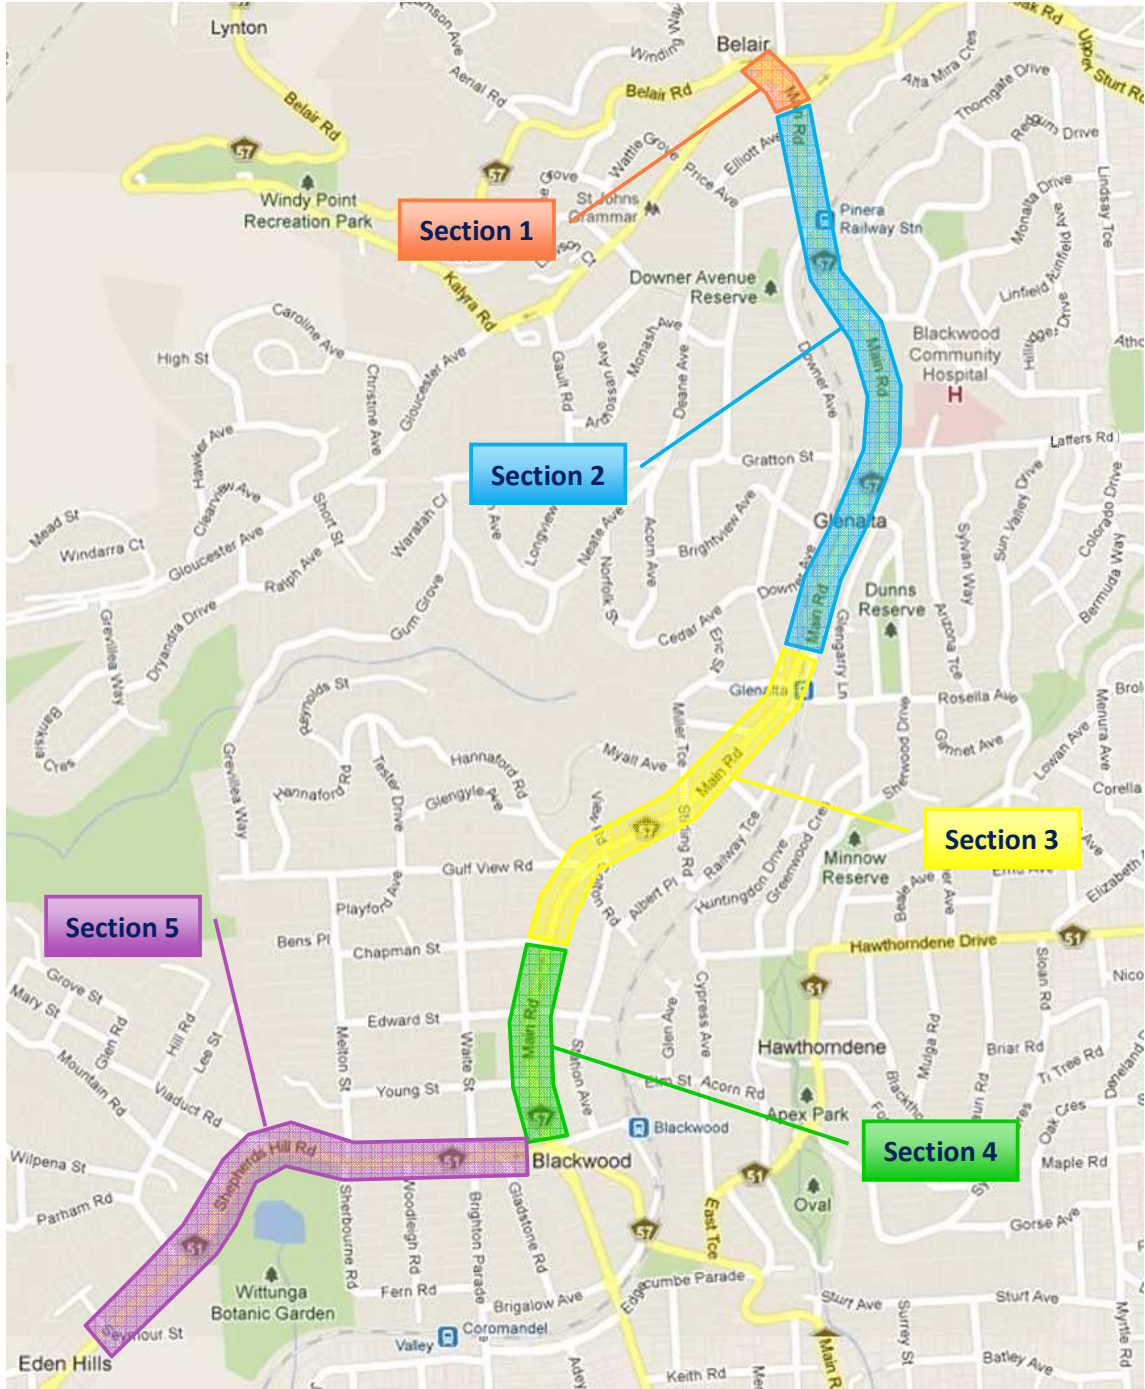
Figure 2.1.1 - Main Road / Shepherds Hill Road study corridor

For the purposes of the report, the road has been divided into five sections of similar cross section and road characteristics (refer to Figure 2.1.1).

- Section 1: Main Road, between Belair Road and Russell Street
- Section 2: Main Road, between Russell Street and Glenalta Level Crossing
- Section 3: Main Road, between Glenalta Level Crossing and Chapman Street
- Section 4: Main Road, between Chapman Street and Blackwood Roundabout
- Section 5: Shepherds Hill Road, between Blackwood Roundabout and Seymour Street

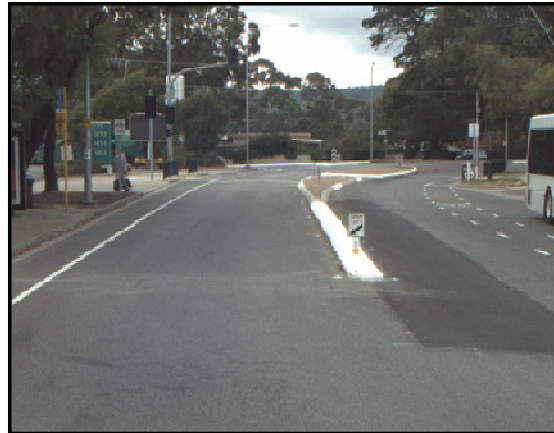
2.3.1 Section 1 – Main Road, Belair Road to Russell Street

This short section lies between Belair Road and Russell Street. The cross section consists of a wide single lane in each direction separated by a raised median. Bicycle lanes 1.5m in width run along both sides of the road.

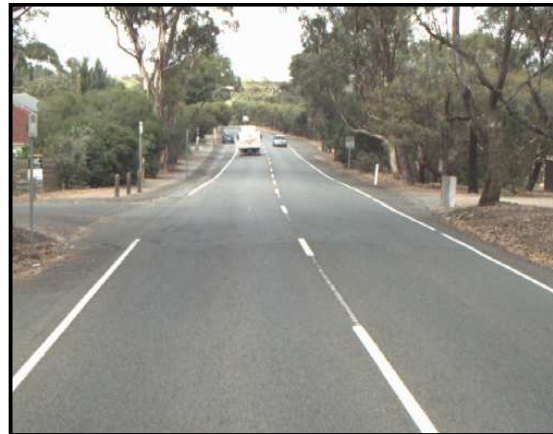
2.3.2 Section 2 – Main Road, Russell Street to Glenalta railway level crossing

This section of Main Road is predominantly fronted by residential homes and is narrow winding its way down to the Glenalta railway level crossing. The majority of intersections / junctions do not have channelized right turn treatments. Native trees line the majority of this road section. Parts of the road are unkerbed.

The cross section has one lane in each direction with varying width, but typically 3.5m and shoulders which are narrow. This road section has a high volume of traffic during the peak periods and is susceptible to being slowed by turning traffic, slow moving vehicles as well as passenger and freight trains.

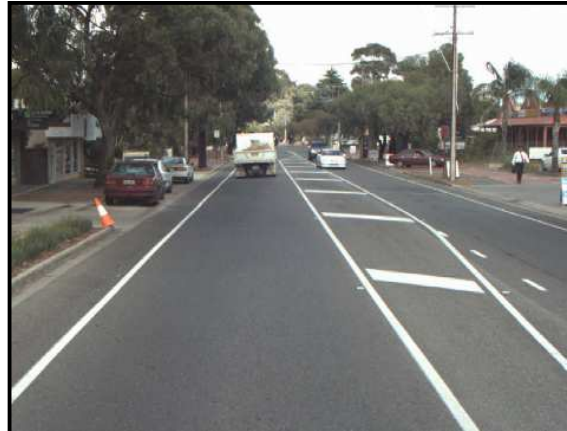
2.3.3 Section 3 – Main Road, Glenalta railway level crossing to Chapman Street

This section continues south from the Glenalta railway level crossing and ends at Chapman Street, where the road widens. Section 3 consists of a varying road width, but typically 3.8m wide lanes in each direction separated by a 3m painted median exist.

For most of the section a 1.5m bicycle lane runs along both sides of the road. Due to the painted median, most of the intersections / junctions have channelised right turn treatments.

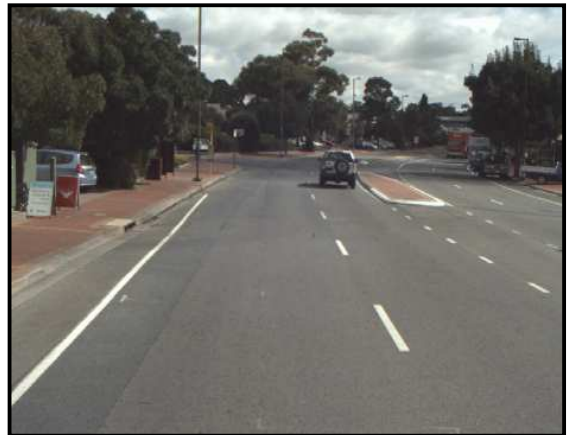
2.3.4 Section 4 – Main Road, Chapman Street to Blackwood Roundabout

Section 4 is a busy stretch of road with a high level of pedestrian activity and on-street parking movements. The section consists of two 3m lanes in each direction separated by a painted or raised median.

2.3m parallel parks are also provided on both sides of the road, where permissible. The section allows access to/from two major supermarkets and other commercial centres.

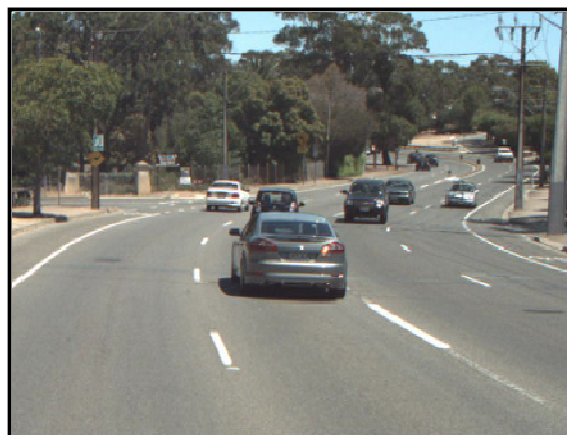
2.3.5 Section 5 – Shepherds Hill Road, Blackwood Roundabout to Seymour Street

Shepherds Hill Road comprises of 2 lanes in each direction. Cyclist lanes are provided on both sides for the majority of the road section. Where this is not the case, a wide kerbside lane is provided. The road varies from being separated by a 3m raised median to a single painted dividing line.

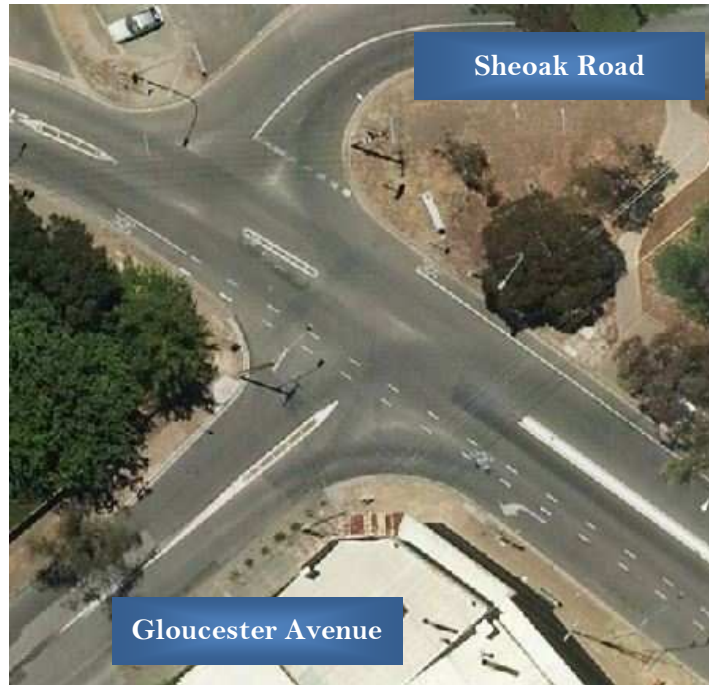
Figure 7.1.1.1 - Aerial Image of Junction (2012)

Gloucester Avenue is located on the inside of a sweeping bend between Belair Road and Russell Street. There is a separate channelised left turn lane from Main Road as well as bicycle lanes in both directions. The junction is located within close proximity to Sheoak Road creating a staggered T-junction.

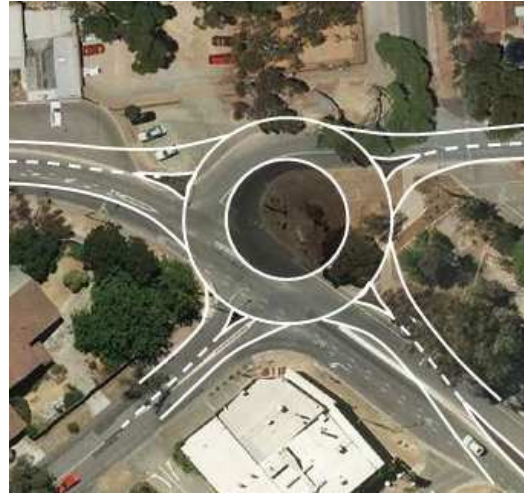
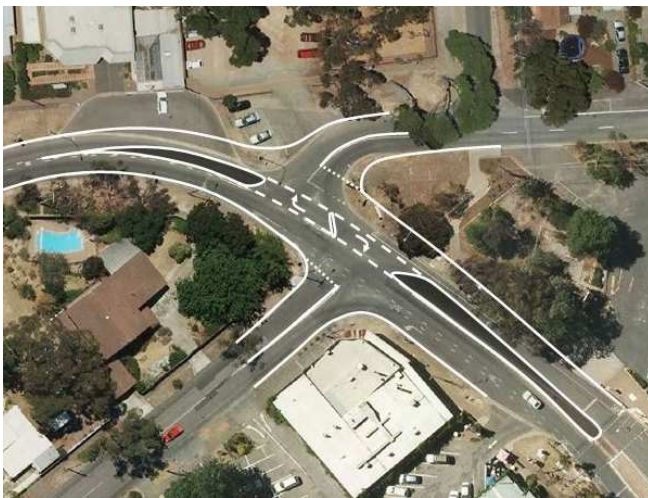
The four leg roundabout was considered to address the right angle crashes and provide greater priority to vehicles exiting right out of Gloucester Avenue. The roundabout would require southbound vehicles on Main Road to give way to right turning vehicles exiting Gloucester reducing the potential for right angle crashes. Additionally, the roundabout would remove the visibility issues experienced by the right turning vehicles from Gloucester Avenue as they will no longer have to judge gaps in southbound traffic on Main Road or monitor simultaneous movements from Sheoak Road to Gloucester Avenue. The roundabout would require vehicles on Main Road to give way introducing nominal travel time delay. Both Gloucester Avenue and Sheoak Road would experience similar levels of delay and queuing as currently experienced. The roundabout would require significant roadwork's and land acquisition attracting a high cost for implementation.

A second option for this location is a channelised right turn treatment along Main Road. The treatment would provide a sheltered area for vehicles to wait before turning right into Gloucester Avenue and Sheoak Road. It would also provide vehicles exiting right out of Gloucester Avenue an opportunity to perform a two stage manoeuvre by storing in the middle of the road and reduces the potential for right angle crashes. Vehicles would still experience the same level of delays and queues on both side roads as currently experienced.

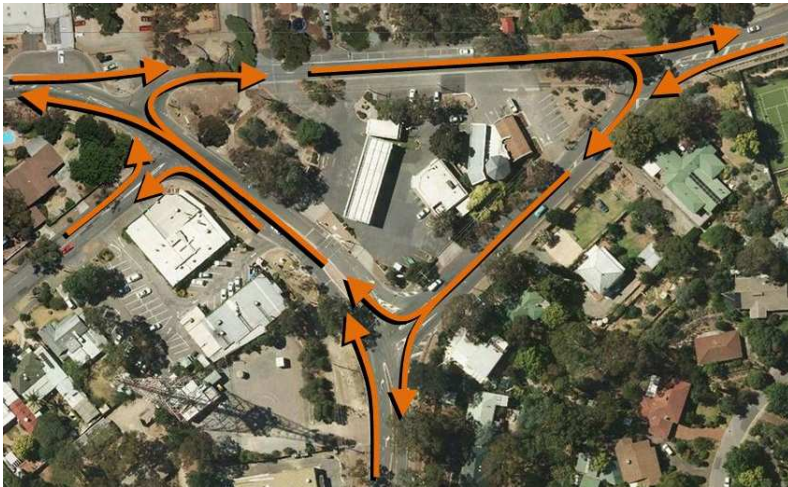
The one-way triangle was considered as a network treatment to reduce the potential for crashes at Russell Street. The treatment requires all vehicles approaching the triangle to circulate in a clockwise direction along Main Road, Sheoak Road and Russell Street. The treatment would improve safety for all roads intersecting the triangle by reducing the number of turning movements at each junction which would

simplify the road environment for motorists. However the one-way triangle would result in increased travel time delays through the area. Traffic modelling indicated the triangle operated worst in the weekday morning peak period with Gloucester Avenue and Belair Road experiencing noticeable queues and delays compared to existing conditions. The treatment would also introduce weaving manoeuvres over short distances between the junctions which would increase the potential for mid-block crashes around the triangle. Due to the increase in overall travel time delay and the increased potential for mid-block crashes this option is not considered viable.

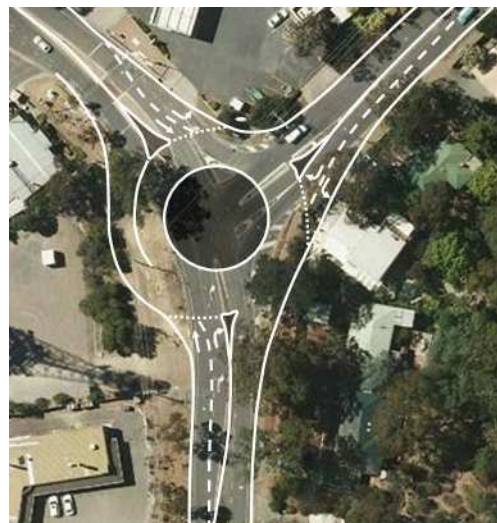
A roundabout has also been considered to primarily address the right angle/turn crashes and provide greater priority to vehicle movements to and from Russell Street. The roundabout would slow vehicle speeds through the junction, simplify vehicle movements and reduce travel time delays for vehicles exiting Russell Street including buses. The roundabout requires north and southbound vehicles on Main Road to give way introducing travel time delays which are not excessive. The close proximity of the PAC would impact the operation of the roundabout by causing queues back to the roundabout potentially blocking lanes. The roundabout would require considerable roadwork's and land acquisition attracting a high cost for implementation.

A reconfigured T-Junction was considered in order to change vehicle priority at the junction to reflect the predominant traffic movements between Main Road (south) & Russell Street and to address the right angle/turn crashes. The T-Junction would require Main Road (north) vehicles to give way to Russell Street traffic and allows uninterrupted traffic flow between Main Road (south) and Russell Street. This treatment removes travel time delays for vehicles moving between Russell Street and Main Road (south), however at the same time would introduce significant travel time delays and queues on Main Road (north) approach which would not be acceptable to road users. This option still presents the same number of conflicting vehicle movements as existing. Some level of land acquisition would be required to implement this scheme.

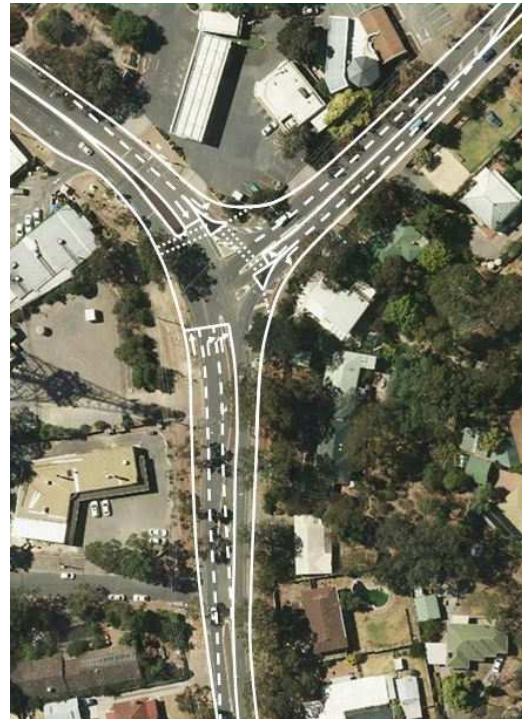
Traffic Signals were also investigated to provide greater priority to vehicle movements to and from Russell Street and to improve safety by controlling conflicting traffic movements through the junction. The traffic signals would require the existing PAC to be removed and integrated within the signals. The traffic signals require north and southbound vehicles on Main Road to stop introducing travel time delays. The right turn out of Russell Street would see an improvement in travel time. Overall, this treatment provides some level of safety improvement. At the same time additional travel time delay and queues are introduced to Main Road traffic however, these are within acceptable limits. The treatment would require considerable roadwork's and land acquisition attracting a high cost for implementation.

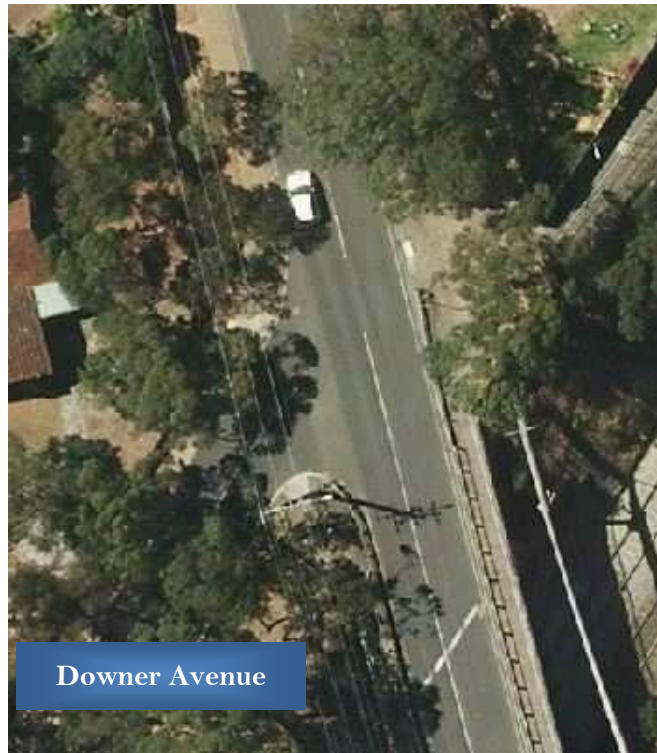
Figure 7.1.3.1 - Aerial Image of Junction (2012)

This junction is located immediately north of the Pinera Railway Station Overway Bridge. The road at this point is narrow due to the road bridge to the south of the junction. Downer Avenue approaches Main Road at a steep incline and meets Main Road at an acute angle. There are no separate channelised left or right turn lanes at this junction and both Main Road and Downer Avenue comprise a single traffic lane in each direction.

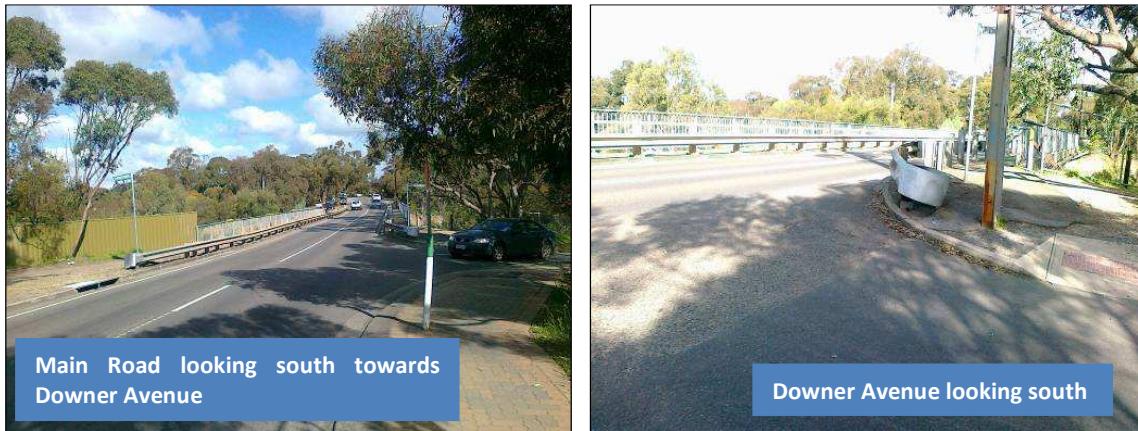
Figure 7.1.3.4 - Main Road/ Downer Avenue

Factors that may have contributed to the crashes at this location include poor sight distance for vehicles exiting the side road due to the steep incline, close proximity of the bridge infrastructure and acute angle at Downer Avenue where it meets Main Road. It is considered there are a high number of crashes at this location for the relatively low volume of turning traffic. Figure 7.1.3.4 illustrates the visibility issues at the junction.

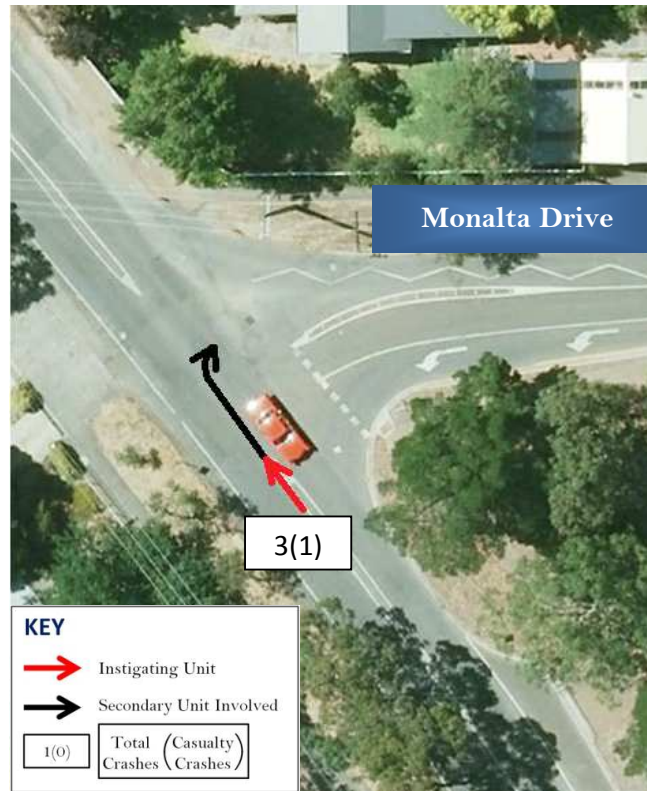
Figure 7.1.4.2 - Crash Diagram (2009 – 2013)

Detailed analysis of the crash data indicates that the rear end crashes all involved northbound vehicles on Main Road colliding with stationary vehicles waiting to turn right onto Monalta Drive. Of these crashes, 2 occurred at night and in wet weather conditions. One of the rear end crashes resulted in a fatality.

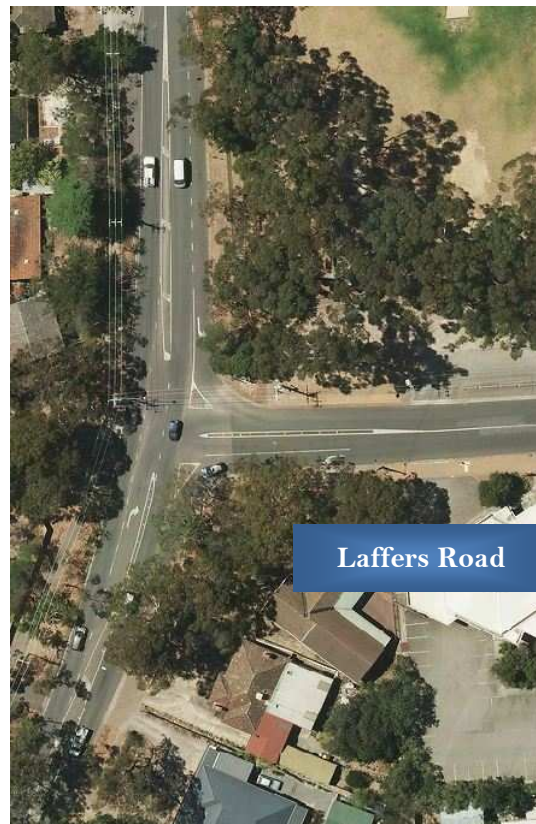
Figure 7.1.5.1 Aerial Image of Junction (2012)

The Laffers Road junction is located on the outside apex of a bend and has a single lane in each direction on Main Road with separate channelised left and right turning lanes for vehicular movements into Laffers Road. Laffers Road flares on approach to Main Road to provide separate left and right turn exit lanes. There is a PAC located approximately 160m north of the junction in front of Belair Primary School.

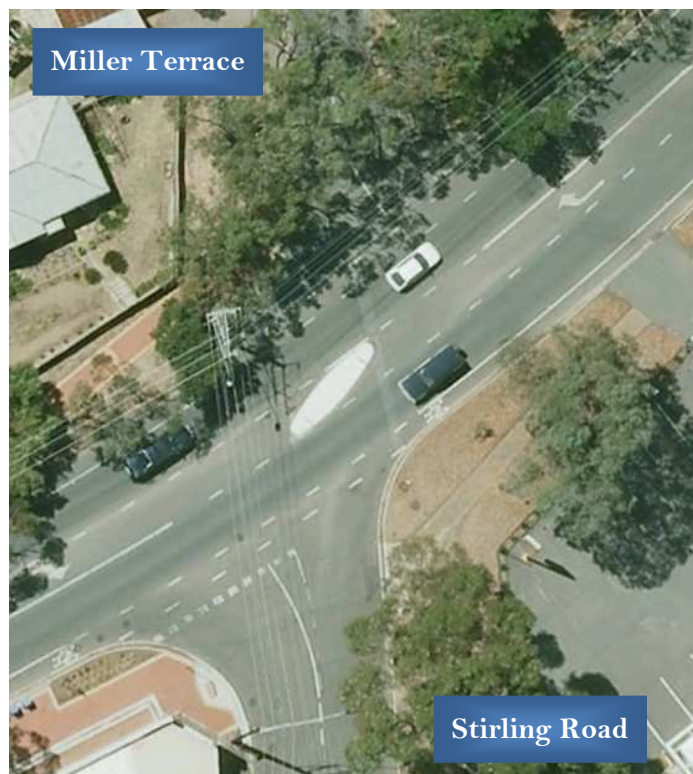
Figure 7.1.7.1 - Aerial of Junction (2014)

This offset junction is located on the south of Burfield Street and north of the View Road and Colton Road junction. Main Road at this location provides one traffic lane and a cyclist lane in each direction as well as a separate channelised right turn lane for vehicles turning right into Miller Terrace and Stirling Road. Miller Terrace has one lane in each direction and Stirling Road also has one lane in each direction with both streets allowing all turning movements onto Main Road.

There is a small solid median in the centre of the junction at the end of both turning lanes to guide commuters through the junction and provide a degree of separation between the turning movements.

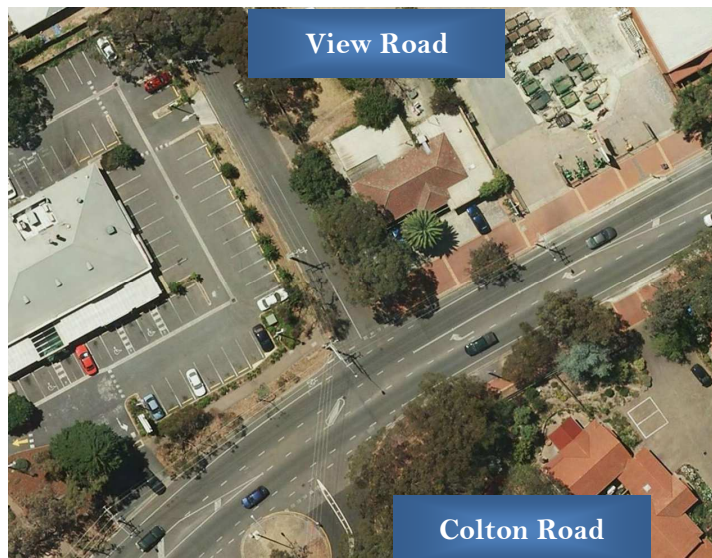
Figure 7.1.8.1 - Aerial Image of Intersection (2012)

This T-junction is located on the outside apex of a bend with the Colton Road junction and a service road access located just south. Main Road at this location provides two traffic lanes and a cyclist lane in each direction as well as channelised right turn bays on Main Road to allow vehicles turning right into the side roads to safely wait without slowing through traffic on Main Road. The channelised treatment also provides motorists the opportunity to make the right turn out manoeuvre from View Road and Colton Road safely in two stages. There is a short section of painted median located between View Road and Colton Road to separate turning traffic and to prevent unsafe straight through movements between the side roads.

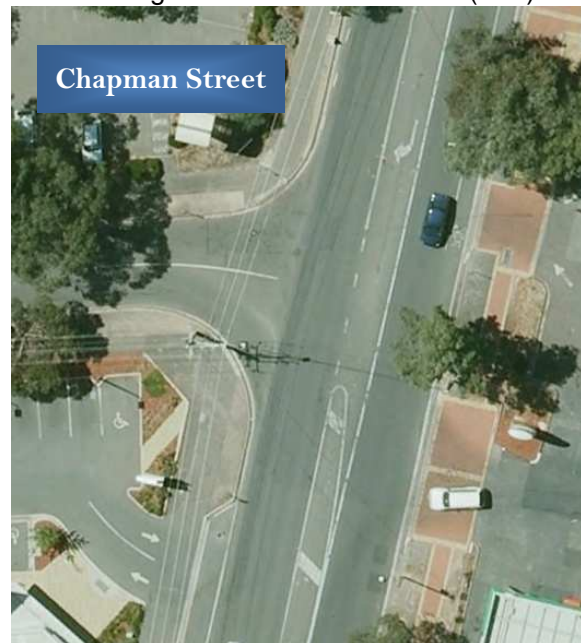
Figure 7.1.10.1 - Aerial of Junction (2014)

This junction is located south of Gulfview Road and north of Edward Street. Main Road at this location provides one traffic lane in each direction as well as a separate channelised right turn lane for vehicles turning right into Colton Road.

There is a painted median either side of the turning lane into Chapman Road along Main Road. To the south of Chapman Street the road widens to form two traffic lanes in each direction while still providing a bike lane either side of the road. Access to the BP is also provided directly opposite the T-junction adjacent the right turn lane into Chapman Street.

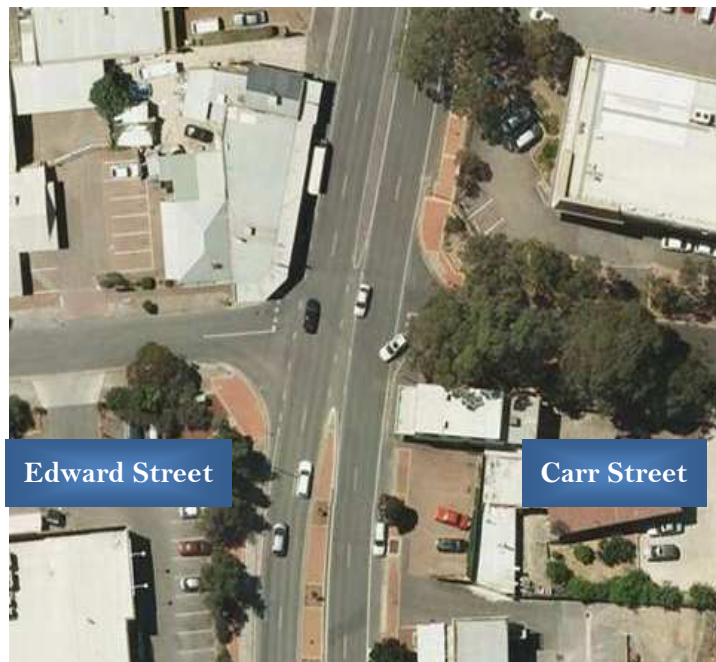
Figure 7.1.11.1 - Aerial Image of Intersection (2012)

Carr Street provides access to the Blackwood Library as well as retail, residential dwellings and the Blackwood Station, further south of the intersection. Currently a number of vehicles use this intersection to perform u-turns.

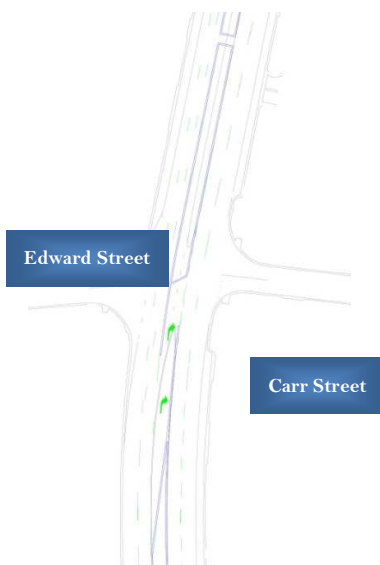
Providing a channelised right turn treatment into Edward Street would improve the safety at the intersection by reducing the number of conflicting vehicular movements permitted at the intersection as well as providing a separate storage area for vehicles waiting to turn right in to Edward Street. This treatment would result in movement restrictions at this intersection, including no access to Carr Street or the Blackwood Library from the south. It would also impact on the ability to perform at u-turn heading north.

Similarly, providing a channelised right turn treatment into Carr Street would improve the safety at the intersection by reducing the number of conflicting vehicular movements permitted at the intersection as well as providing a separate storage area for vehicles waiting to turn right in to Carr Street. This option would also result in movement restrictions at the intersection, including no access to Edward Street from the north impacting access to a substantial amount of off-street parking associated with retail and supermarket facilities in Blackwood as well as delivery vehicle access to Coles. Albeit, access from the north to these facilities is also available via Chapman Street and Young Street with both of these junctions providing a sheltered right turn lane allowing right turn vehicles to store without impeding through traffic along Main Road.

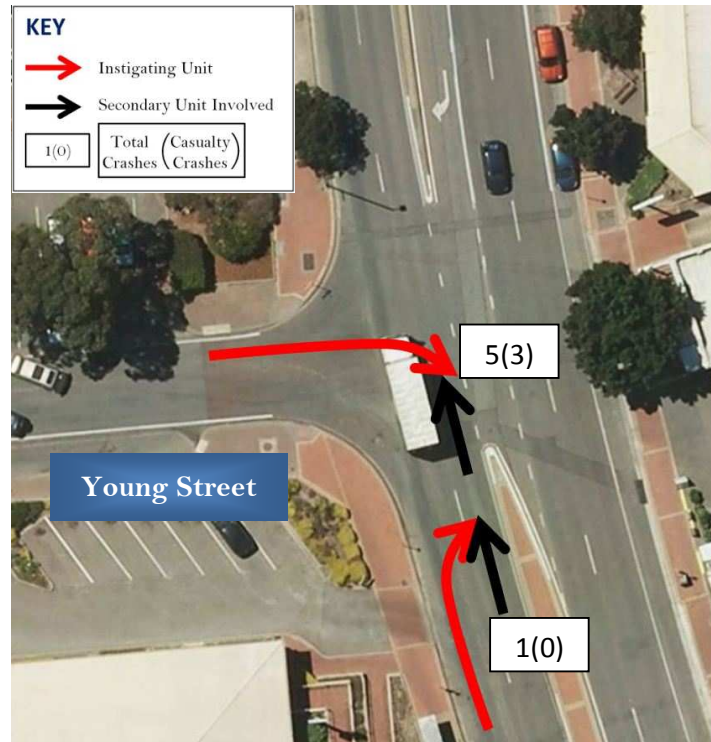
Figure 7.1.12.2 - Crash Diagram (2009 – 2013)

Detailed analysis of the crash data indicates that five of the six crashes at the junction involved vehicles turning right out from Young Street colliding with a northbound vehicle on Main Road, all of which occurred during business hours. The fourth crash resulted when a northbound vehicle changed lanes and side swiped a vehicle in the adjacent lane.

Factors that may have contributed to the 'right angle' crashes at this location include the volume of traffic turning to and from Young Street associated with the businesses, reduced visibility to the south due to the proximity of roadside vegetation and stopping/slowing down buses and/or vehicles (to turn left into Young Street) in the kerbside lane obscuring northbound cars in the outside lane.

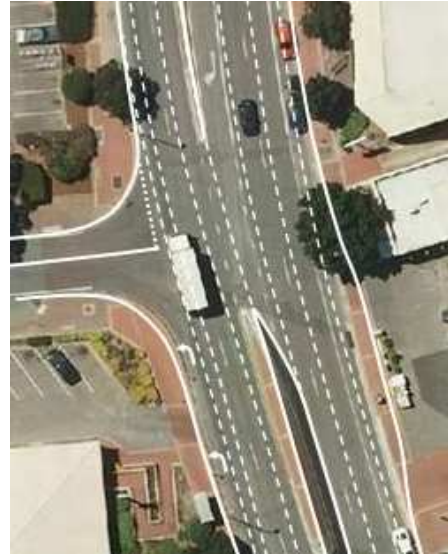
A separate channelised left turn lane has been considered in order to address the right angle crashes at the junction by separating out left turning vehicles from the northbound through traffic. This would allow motorists on Young Street to see past the left turning vehicles as well as assisting them to judge the behaviour and movements of northbound traffic passing the junction. The separate channelised left turn lane would also act as an indented bus stop and would allow vehicles exiting Young Street to see past stationary buses again improving the visibility from the side road.

On review of the crash data it is recommended the vegetation to the south be trimmed back or removed and the channelised left turn lane be installed. Given there has only been two casualty crashes during the past five years, this treatment would be considered a low priority when compared against other state-wide priorities.

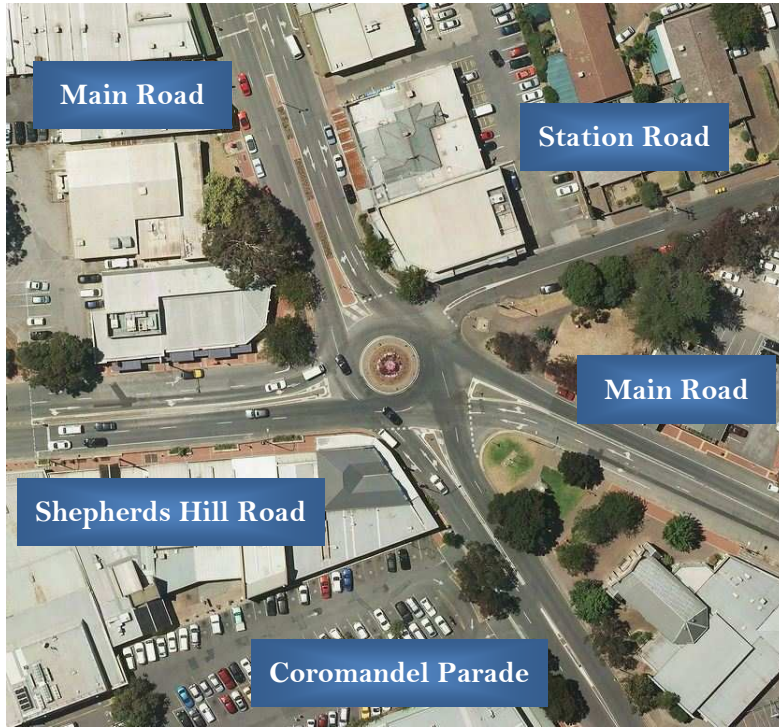
Figure 7.1.13.1 Aerial Image of Intersection (2012)

Indented kerbside parking is provided along both sides of Main Road, north and south of the roundabout whereas on-street kerbside parking is provided on the northern side of Shepherds Hill Road between the PAC and the roundabout. A level crossing is located south of the roundabout on Main Road adjacent to the Blackwood Interchange. The railway line services both passenger and freight trains.

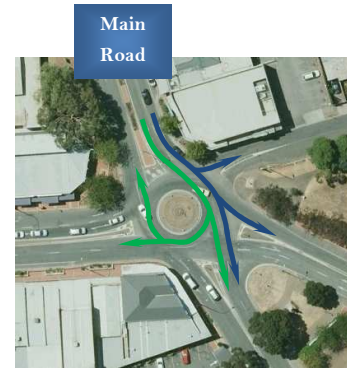
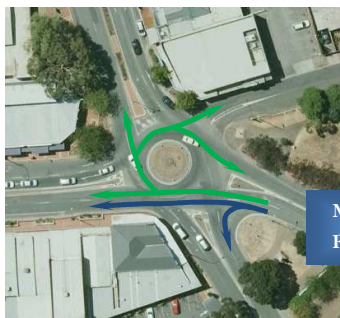
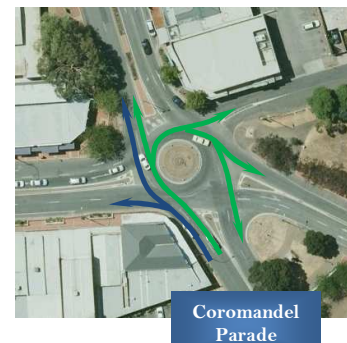
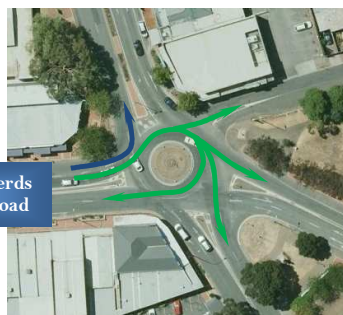
Main Road (north) approach has a shared through and left turn lane (kerbside lane) and a shared through and right turn lane (median lane). The through movement from Main Road (north) is to Coromandel Parade. This approach experiences its peak traffic demand during the weekday evening peak period.

Main Road (south) approach has a short shared through and left turn lane (short kerbside lane) and a shared through and right turn lane (median lane). The through movement from Main Road (south) is to Shepherds Hill Road. This approach experiences its peak traffic demand during the weekday morning peak period.

Coromandel Parade approach has a short shared through and left turn lane (short kerbside lane) and a shared through and right turn lane (median lane). The through movement from Coromandel Parade is to Main Road (north). This approach experiences its peak traffic demand during the weekday morning peak period.

Shepherds Hill Road approach has an exclusive left turn lane (kerbside lane) and a shared through and right turn lane (median lane). The through movement from Shepherds Hill Road is to Main Road (south). This approach experiences its peak traffic demand during the weekday evening peak period.

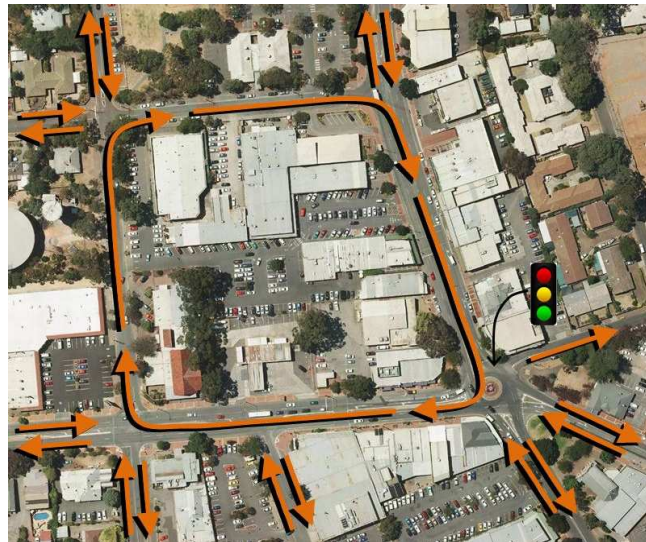
A one-way loop was considered as a network treatment to reduce the potential for crashes at the Blackwood Roundabout with minimal widening and land acquisition. The treatment requires all vehicles approaching the one-way loop to circulate in a clockwise direction along Main Road, Shepherds Hill Road, Waite Street and Young Street. The conflicting vehicle movements where Main Road (south) and Coromandel Parade intersect the one-way loop would be controlled using traffic signals. The treatment would improve the safety at all the locations where roads intersect the one-way loop by reducing the number of turning movements at each junction including the intersection of Shepherds Hill Road with Brighton Parade and Waite Street as well as the Main Road junction with Young Street.

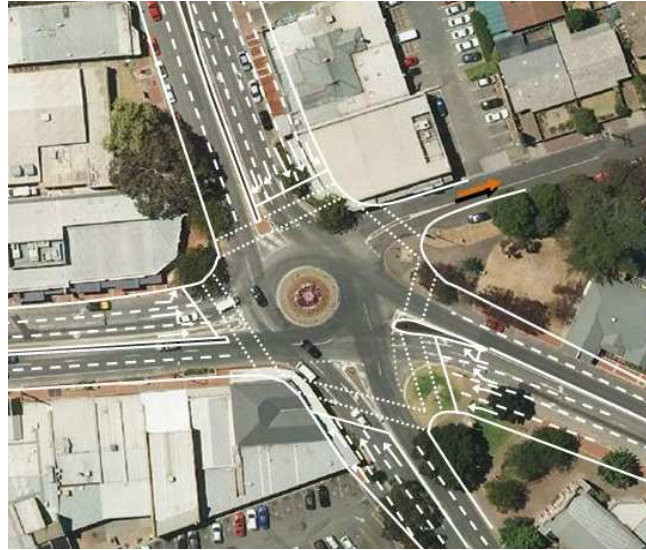
Traffic signals were also investigated to improve the safety at the intersection by controlling conflicting traffic movements. Traffic signals would provide greater priority to Coromandel Parade traffic during the weekday morning peak period and Main Road (north) traffic during the weekday evening peak period. Traffic signals also allow for the provision of control measures to minimise the risk of vehicles queuing over the rail level crossing to the south-east of the junction. This treatment would include pedestrian crossing facilities improving the pedestrian access at the intersection, although the considerable amount of road widening required on approaches to the intersection would significantly impact the character of the area in an

undesirable manner given this area is a pedestrian precinct within the heart of Blackwood. The traffic signals would require a significant amount of road widening including the removal of on-street parking for extended lengths on all approaches to the roundabout as well as movement restrictions at the intersection impacting bus circulating routes through the Blackwood Interchange and reducing access to local businesses in order to achieve travel times through the intersection and approach queues that are within acceptable limits. Traffic signals would increase the speed at which vehicles can negotiate the intersection in comparison to a roundabout resulting in increased vehicle speeds on approaches to the intersection and through the pedestrian precinct. This treatment was previously investigated in the 2006 RMP and has been reassessed using more recent traffic volume data. The findings reported in the 2006 RMP are consistent with the findings from recent modelling. Traffic modelling indicates that traffic signals at this intersection with no significant alterations to the current geometry, other than Station Road operating as in only, would result in the intersection operating far worse than it does currently during the weekday morning and evening peak periods with an additional three to five minutes of travel time delays for vehicles moving through the intersection, on top of current delays experienced, and an increase in the number of vehicles queued at the intersection with up to an additional 200 vehicles queued on an approach to the intersection. Traffic modelling indicates that with substantial road widening and movement restrictions at the intersection travel times for vehicles on Main Road (north) and Shepherds Hill Road would improve during the weekday evening peak period which is predominantly achieved through the significant amount of road widening on Main Road (north) approach. However traffic modelling also suggests that traffic signals would result in an increase in travel times through the intersection for all vehicles during the weekday morning peak period with travel times for traffic on Main Road (south) and Main Road (north) predominantly impacted, albeit these are within acceptable limits. At this stage traffic signals are not considered to be the most appropriate treatment at this location as the signals do not provide any significant improvement to the operation of the intersection, require a substantial amount of road widening on the approaches, significantly detracting from the desired character of the commercial precinct, as well as contributing to a faster speed environment at the intersection and through the pedestrian precinct.

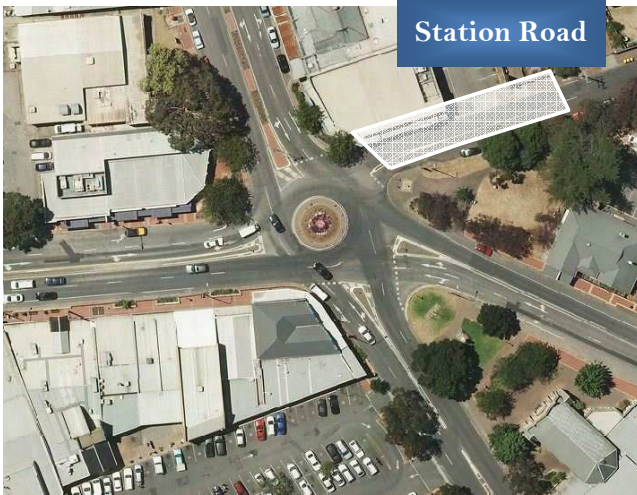
Removing one leg of the roundabout was considered to improve the safety at the intersection by reducing the complexity and number of vehicle movements at the roundabout. Discussed below are the two scenarios investigated as options for reducing the number of approach and exit legs at the roundabout.

The removal of Station Road would reduce the number of approach and exit legs at the intersection resulting in the roundabout resembling more of a standard 4-leg roundabout. This treatment would assist vehicles to select the correct lane as they approach the roundabout as well as reducing the number of conflict points and entry points that motorists need to monitor when judging gaps in circulating flow on the roundabout. Although due to the low volume of traffic using Station Road this option would not improve travel times for vehicles moving through the intersection. This treatment would

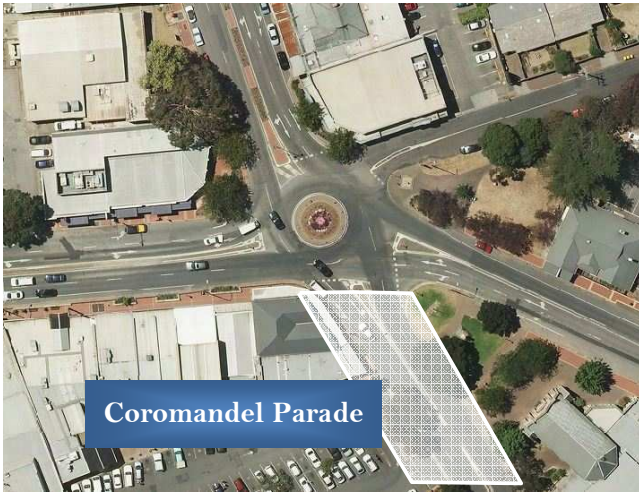
The removal of Coromandel Parade would also result in the roundabout resembling more of a standard 4-leg roundabout. This has been considered as a network treatment to simplify the operation and reduce the number of vehicular conflict points on the roundabout. Current traffic survey data in the area suggests that south to west vehicle movements (and vice-versa) to and from Shepherds Hill Road west of the roundabout predominantly occur via local roads including Gladstone Road and Brighton Parade. Accordingly this treatment would predominantly impact traffic movements between Coromandel Parade and Main Road north of the

roundabout requiring this traffic to use alternative travel routes to access Main Road. This treatment would improve the pedestrian safety on Coromandel Parade adjacent the intersection by reducing the volume of traffic and speed environment near the retail facilities on the south-west corner of the intersection but will also reduce vehicle access to these retail facilities. If a link road connecting Coromandel to Main Road south of the roundabout was created traffic modelling indicates that there would be no improvement to vehicle travel times through the roundabout. A roundabout at the Shepherds Hill Road intersection with Brighton Parade and Waite Street would provide a safe alternative for the Coromandel Parade traffic to access the local road network however traffic modelling indicates that travel time delays at the Blackwood Roundabout would be similar to that currently experienced assuming most of the northbound traffic still uses the Blackwood Roundabout. Additionally the Department would need to work with Council to discuss access issues associated with the removal of the Coromandel Parade leg of the Blackwood Roundabout. Given this network treatment would require a significant review of the access and traffic flows within the Blackwood area it is not perceived to be a short to medium term treatment and hence this treatment is considered to be outside of the scope of this report.

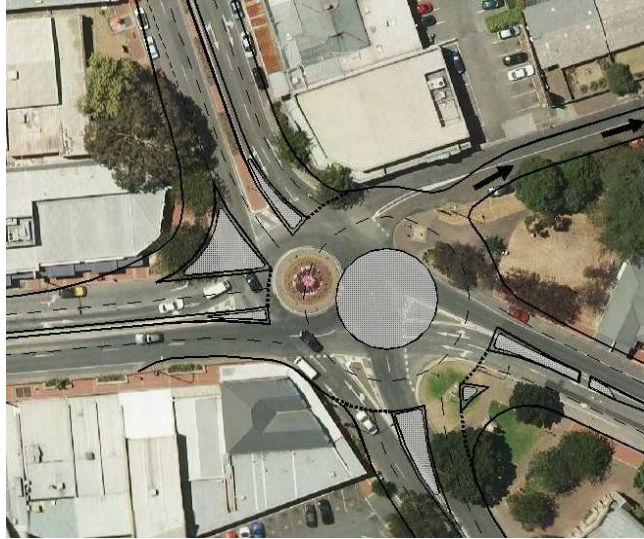
Altering the geometry of the roundabout would improve the safety at the intersection by remodelling the roundabout to be more like a standard 4-leg roundabout. This treatment would limit Station Road to in only access to simplify the operation and reduce the number of vehicular conflict points on the roundabout while maintaining the access into the Blackwood Interchange for buses and the community. The removal of an entry into the roundabout would also reduce the number of entry points that motorists need to monitor when judging gaps in circulating flow on the roundabout. This treatment would lower vehicle entry speeds into the roundabout by increasing the size of the roundabout island. The alterations to

The alterations to the roundabout would improve the visibility for vehicles entering the roundabout and improve motorist's ability to judge gaps in circulating traffic flows on the roundabout by increasing the distance between and alignment of approach legs as well as lowering the speed of vehicles circulating the roundabout. This treatment would also improve the left turn from Main Road (south) to Coromandel Parade for buses and allow for a pedestrian refuge island on Main Road (south) improving pedestrian facilities and access across Main Road (south). This treatment would improve the safety at the intersection without negatively impacting the character of the area and maintaining access within the Blackwood commercial precinct. Traffic modelling indicates that during the weekday morning peak the critical approaches, Main Road (south) and Coromandel Parade, experience similar travel times through the roundabout when compared to current operation, while there is some improvement in travel times through the intersection for Shepherds Hill Road traffic. The traffic modelling also indicates that the vehicle travel times through the intersection for traffic on Shepherds Hill Road and Main Road (north) are significantly improved by halving the current delays experienced by vehicles on these approaches during the weekday evening peak period. The operational improvement evident in the weekday evening peak period is attributed to the additional through lane from Shepherds Hill Road to Main Road (south) increasing the volume of vehicles that can enter the roundabout from Shepherds Hill Road.

In order to achieve the geometric alterations there would be a significant amount of road works required including relocation of the War Memorial monument, reduction to the parklands area and possibly some land acquisition, attracting a high cost for implementation.

It is recommended that the geometry at the roundabout be altered due to this treatment providing a reasonable balance between an improvement to the safety and the operation of the intersection while maintaining the character of the area and access within the commercial precinct. The community has raised significant concern regarding the impact of this recommendation on the war memorial and parklands. It should be noted that the concept shown above has not been finalised and the project itself is unfunded and needs to be prioritised against other state-wide projects. Concerns relating to the location of the monument are acknowledged and its location will be considered and further consultation will occur with the further development of the concept.

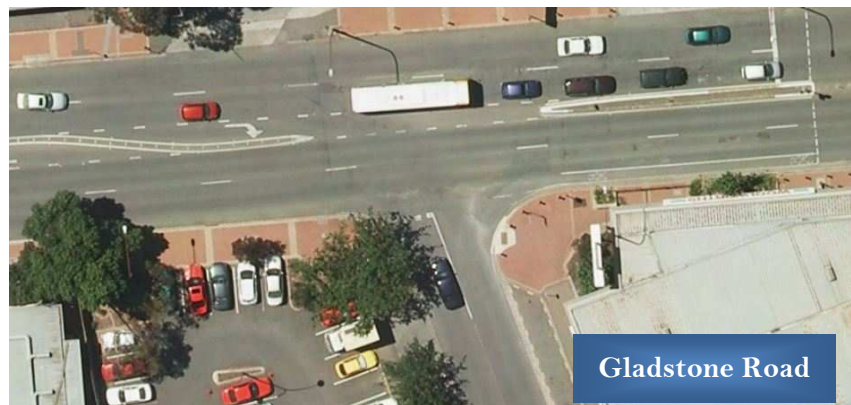
Figure 7.1.14.1 - Aerial Image of Junction (2012)

The junction of Shepherds Hill Road and Gladstone Road is located within the commercial precinct in the heart of Blackwood. Shepherds Hill Road at this location provides two traffic lanes in each direction as well as a separate channelised right turn lane for vehicles turning right into Gladstone Road. Gladstone Road provides a single traffic lane in each direction, with indented kerbside parking permitted along both sides of the road. There is a PAC on Main Road just east of Gladstone Road.

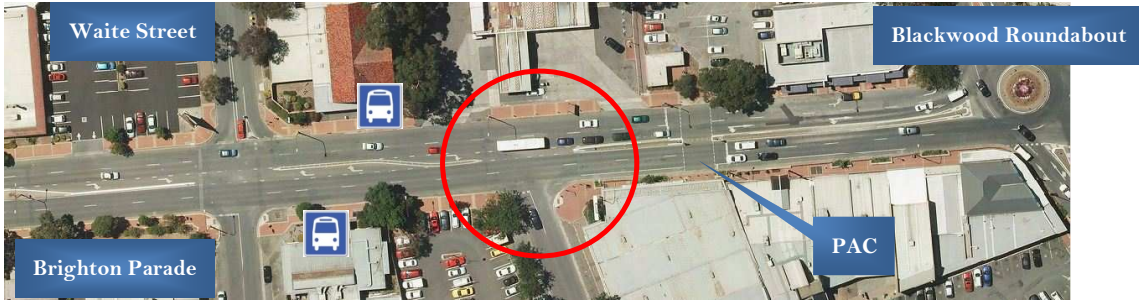
Figure 7.1.14.3 - Location of Gladstone Road junction along Shepherds Hill Road

Gladstone Road provides access to a substantial amount of parking for the surrounding retail facilities, residential dwellings and other community facilities. The land use surrounding the junction generates high volumes of pedestrians and turning vehicles. Site observations revealed that there is a substantial level of vehicle movement between this junction and the surrounding road network i.e. interactions with the PAC, Blackwood Roundabout and Waite/Brighton Parade intersection, as illustrated in Figure 7.1.11.3 below.

The junction is used to bypass Blackwood roundabout to access Corromandel Parade and vice-versa. The PAC assists the operation of the junction by providing greater opportunity for vehicles to turn right into and left out of Gladstone Road by stopping westbound traffic when activated. Vehicles turning right into or left out from Gladstone Road were observed as exhibiting assertive behaviour i.e. not always stopping before turning, turning at high speeds and choosing small gaps in the traffic.

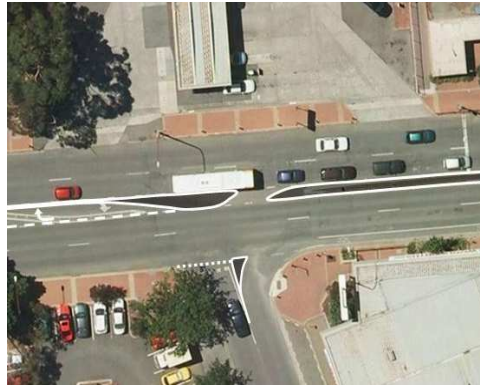
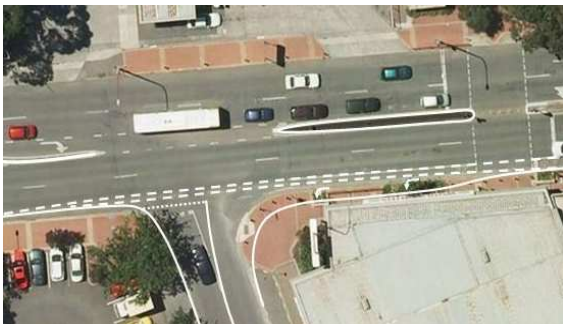
Banning the right turn into Gladstone Road was considered to eliminate the right turn crashes at the junction by removing the movement associated with these crashes. This treatment would require vehicles that currently turn right into Gladstone Road to access the local road network and facilities south of Shepherds Hill Road via alternative roads with Brighton Parade and Coromandel Parade being the most likely to attract vehicles. The implementation of a roundabout at the Shepherds Hill Road intersection with Brighton Parade and Waite Street would provide a safe alternative for those currently turning right into Gladstone Road that are accessing residential properties further south of Shepherds Hill Road (see Section 7.1.11). Impacts to retail facilities adjacent the junction are unknown at this stage, albeit the Department would need to work with Council to address any possible access issues.

A separate channelised left turn lane has been considered in order to address the right angle crashes at the junction as it would separate out left turning vehicles from the through traffic approaching the junction from the east. This would allow motorists on the side road to be able to see past left turning vehicles improving the visibility from Gladstone Road as well as assisting motorists waiting on the side road to judge the behaviour and movements of traffic approaching from the south. This treatment

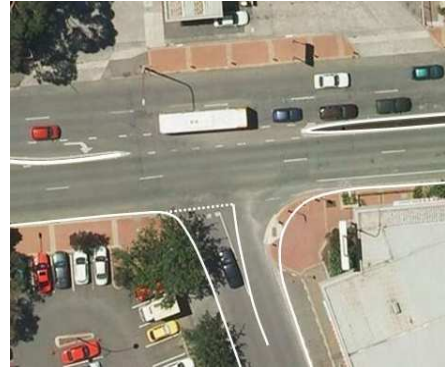
Realigning the junction so that Gladstone Road meets Shepherds Hill Road at a 90 degree angle has been considered to address the right angle crashes at the junction. This treatment would improve the visibility for vehicles exiting Gladstone Road by reducing how far motorists need to turn their head to see oncoming traffic from the east along Shepherds Hill Road. This treatment would require some road widening. Again, given the reduction in right angle crashes that have occurred since the speed limit was lowered on Shepherds Hill Road this treatment is not considered viable at this stage.
