ROAD MANAGEMENT PLAN
EDITION 2
(SHORT TO MEDIUM TERM)

MAIN ROAD (RN6452)
(Belair Road to Shepherds Hill Road)
SHEPHERDS HILL ROAD (RN6467)
(Main Road to Seymour Street)

February 2015

Transport Services Division
Document # 6923461

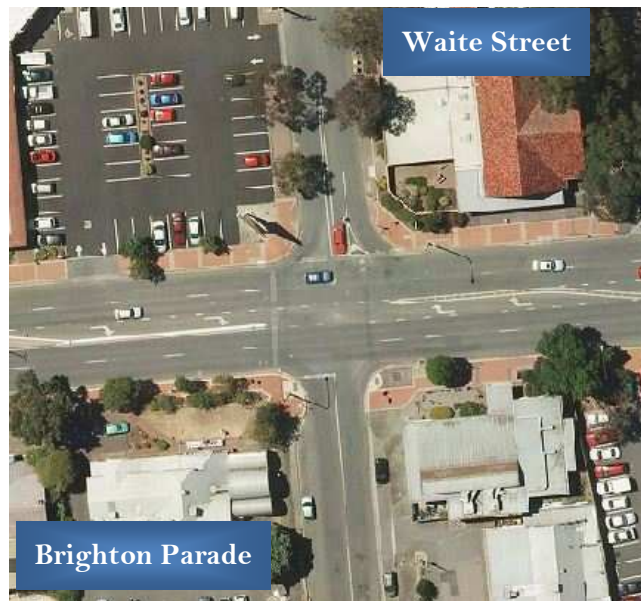
Figure 7.1.15.1 - Aerial Image of Intersection (2012)

Shepherds Hill Road at this location provides two traffic lanes in each direction as well as a separate channelised right turn lanes for vehicles turning right into Waite Street and Brighton Parade. Waite Street provides a single traffic lane in each direction and flares on the approach to Main Road to provide separate left and right turn lanes under 'stop' control. Brighton Parade provides a single traffic lane in each direction with indented kerbside parking on both sides. Brighton Parade is also under 'stop' control.

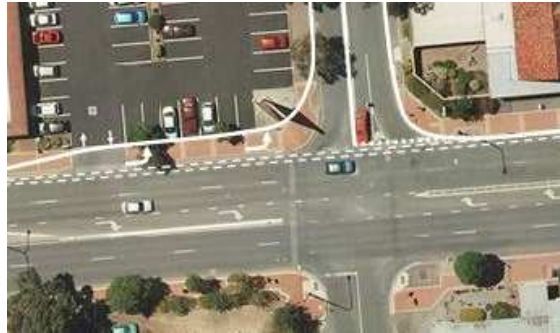
A separate channelised left turn lane into Waite Street has been considered to address the right angle crashes at the junction as it would separate out left turning vehicles from the through traffic approaching the junction from the west. This would allow motorists on the side road to be able to see past the turning vehicles improving the visibility from Waite Street as well as assisting them to judge the behaviour and movements of eastbound traffic.

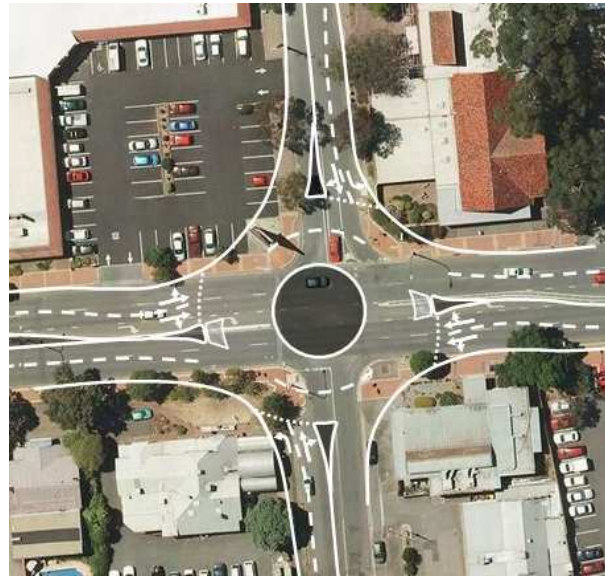
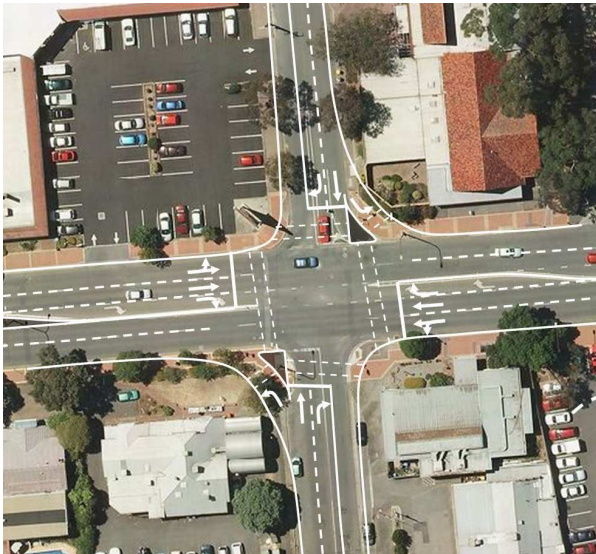
A roundabout has also been considered to primarily address the right angle/turn crashes at the intersection. The roundabout would provide greater priority for vehicle movements to and from the side roads and address just over 85% of the crashes at the intersection (including four of the five casualty crashes). The treatment would slow vehicle speeds through the intersection, simplify vehicle movements, provide pedestrian walk-throughs on approaches to the roundabout and reduce travel time delays for vehicles exiting the side roads. Shepherds Hill Road traffic would be required to give way introducing travel time delays which are not considered excessive. A roundabout at this intersection would create a slower road environment between this intersection and the Blackwood Roundabout providing a safer environment for pedestrian

movements and acting as a Gateway into the Blackwood commercial precinct by indicating a change in road environment to drivers approaching from the west. The roundabout would also provide a safe alternative for commuter traffic currently using the Blackwood Roundabout or Gladstone Road to access residential dwellings south of Shepherds Hill Road. The close proximity of the PAC to the east of the intersection would impact the operation of the roundabout by causing queues back to the roundabout potentially blocking lanes, although queues from the roundabout and the PAC already extend through this intersection during weekday peak operational periods. The roundabout would require considerable road works and some land acquisition attracting a high cost for implementation.

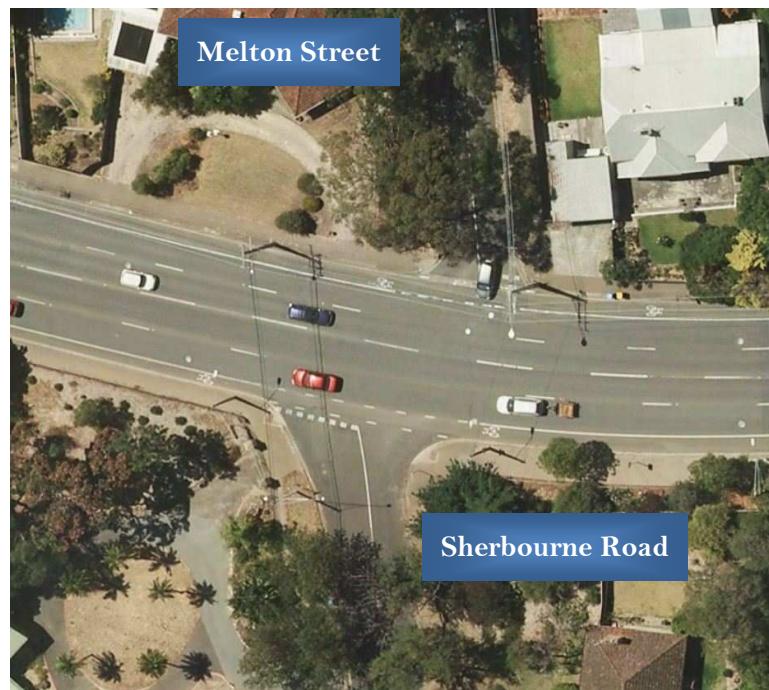
Figure 7.1.16.1 - Aerial Image of Intersection (2012)

Shepherds Hill Road at this location provides a generous cross section with two traffic lanes and a wide bicycle lane in each direction. There are no sheltered right turn lanes for vehicles turning right into either of the side roads. Sherbourne Road and Melton Street each provide a single traffic lane in each direction. There is a sweeping bend just west of the intersection along Shepherds Hill Road.

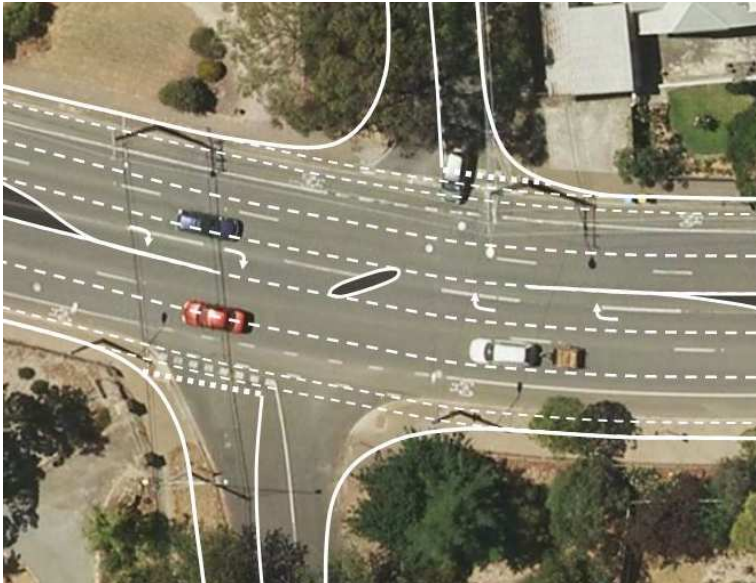
A painted median treatment would be the most appropriate treatment to address the right angle crashes at this intersection. It would provide vehicles exiting right out of Melton Street an opportunity to perform a two stage manoeuvre by storing in the middle of the road reducing the potential for right angle crashes. It would also provide a sheltered area for vehicles to wait

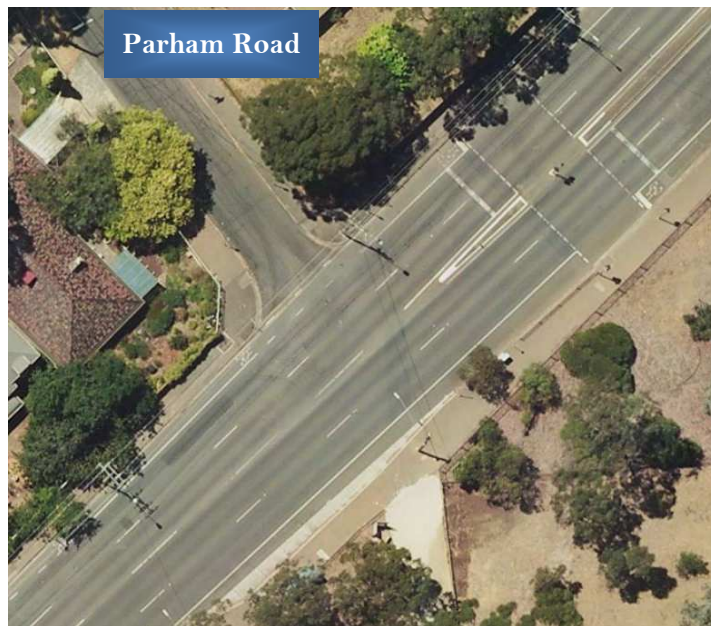
Figure 7.1.18.1 Aerial Image of Junction (2012)

Shepherds Hill Road at this location provides a generous cross section with two traffic lanes in each direction as well as a narrow solid median north of Parham Road. There are no channelised right turn lanes for vehicles to wait while waiting to turning right into Parham Road. Shepherds Hill Road slopes towards the south-west with a sweeping bend north-east of the junction. Immediately north-east of the junction is a PAC. There are bicycle lanes in both directions along Shepherds Hill Road which terminate south-west of the junction. Parham Road provides a single traffic lane in each direction and requires traffic to give way.

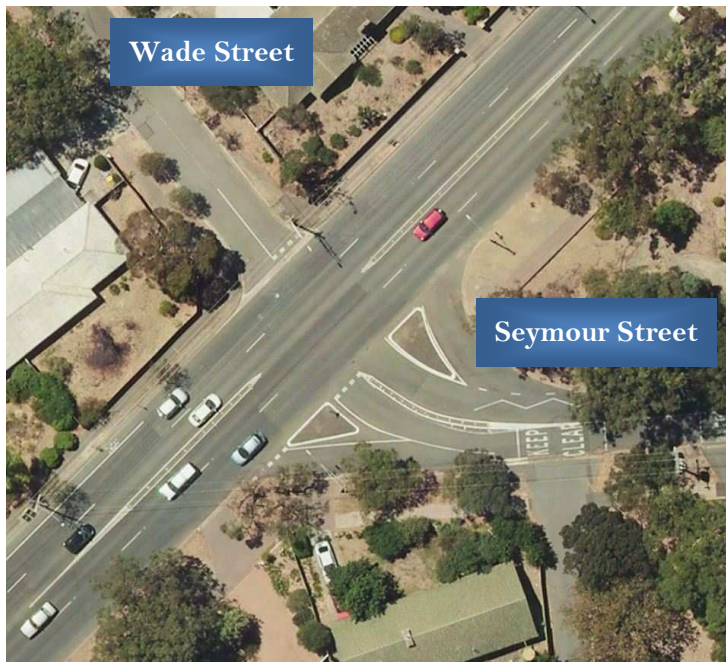
Figure 7.1. 19.1 - Aerial Image of the Intersection (2012)

This 4-way intersection provides two traffic lanes in each direction along Shepherds Hill Road, with a north-bound cyclist lane on Shepherds Hill Road terminating just south of the intersection. There is a narrow painted median on Shepherds Hill Road with raised pavement bars installed to further delineate the approaches to the intersection however there are no sheltered right turn lanes for vehicles turning right into the side roads. Shepherds Hill Road slopes downward travelling in a south-west direction and there is a sweeping bend north-east of the junction along Shepherds Hill Road. Seymour Street flares on approach to Shepherds Hill Road, providing separate left and right turn lanes; there is also some delineation for the left and right turn vehicles as they enter Seymour Street. Wade Street is a narrow side road providing one lane in each direction.

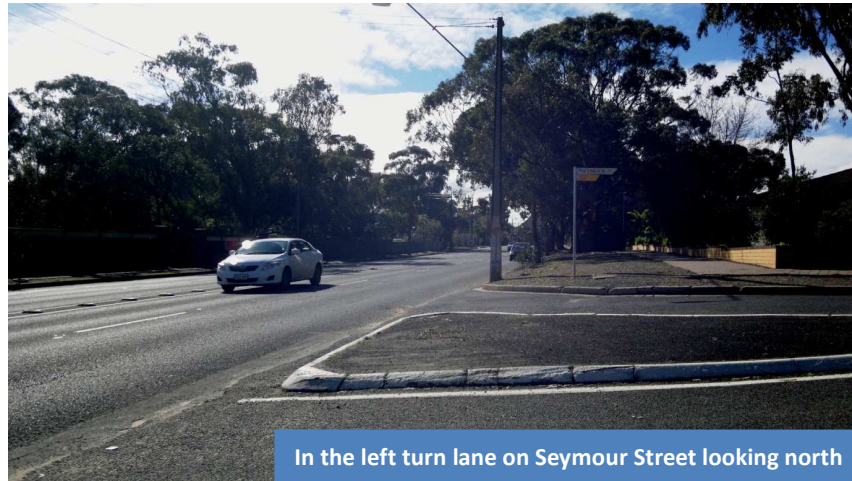
Figure 7.1.19.5 - Shepherds Hill Road / Seymour Street

Seymour Street has been a community issue for a number of years. Long delays have been reported by the community on Seymour Street during the school peak periods.

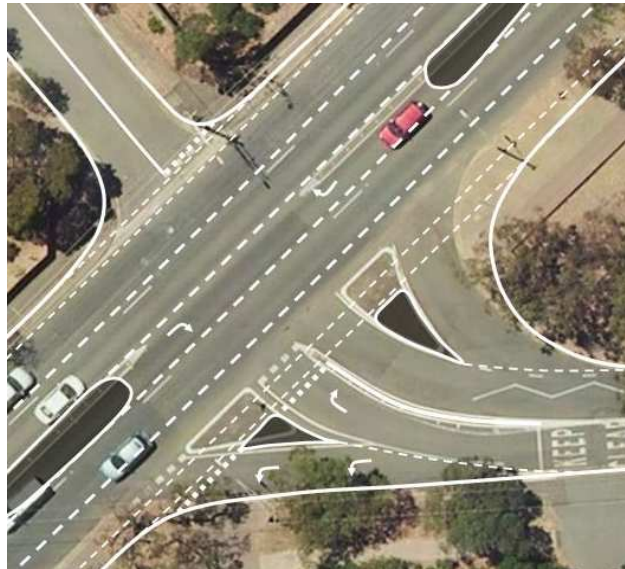
A painted median at the intersection has been considered to address the right angle and rear end crashes at the junction. This treatment would allow vehicles turning right out from Seymour Street to perform a two stage manoeuvre by storing in the middle of the road reducing the potential for right angle crashes. The treatment would also provide a sheltered area for vehicles to wait before turning right into the side roads which would reduce the potential for rear end crashes on Shepherds Hill Road. This treatment would require a substantial amount of road works attracting a reasonably high cost for implementation.

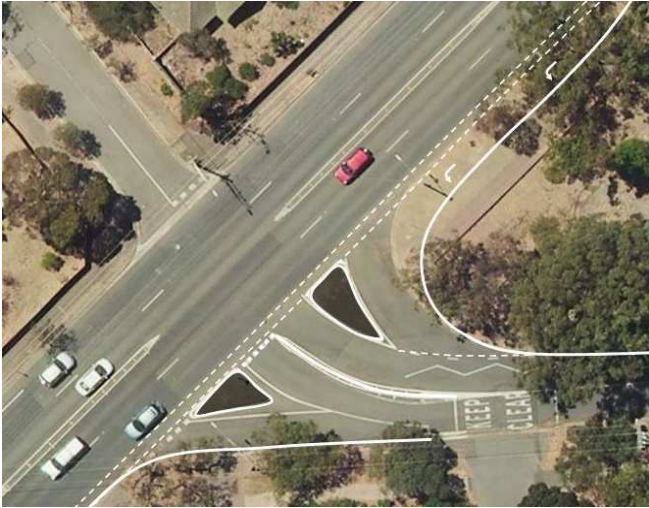
A separate channelised left turn lane has been considered in order to address the right angle crashes at the junction as it would separate out left turning vehicles from the through traffic approaching the junction from the north. This would allow motorists on the side road to be able to see past the turning vehicles improving the visibility from Seymour Street as well as assisting motorists waiting on the side road to judge the behaviour and movements of traffic approaching from the south.

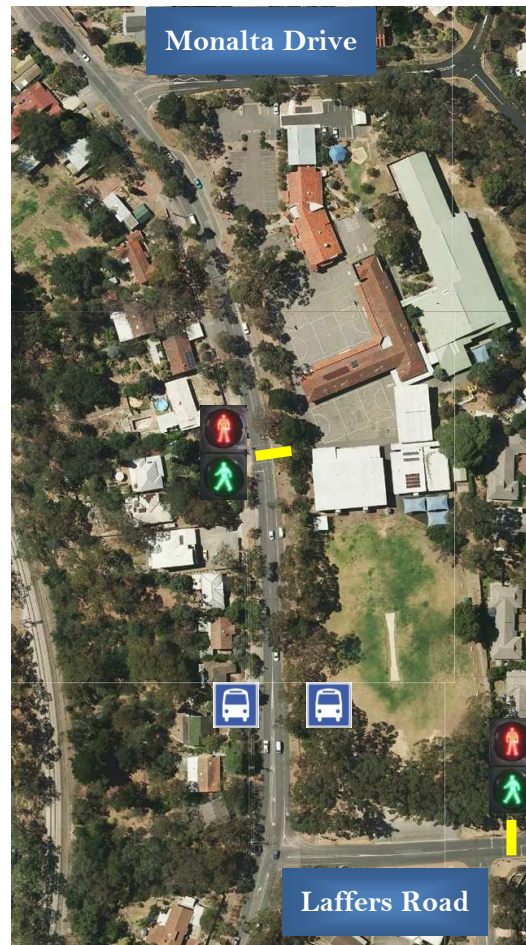
Figure 7.2.1.1 - Aerial Image of Mid-block (2012)

Detailed analysis of the crash data indicates that factors contributing to crashes include the congested traffic conditions during the school peaks, parking vehicles impeding through traffic on Main Road, limited visibility around the sweeping bend and poor visibility of pedestrians and cyclists travelling along the western footpath as illustrated in Figure 7.2.1.1 below. Most of the crashes reported along this mid-block occurred during daylight hours, either the morning or afternoon school peak periods. Both of the head on collisions were reported to be DUI crashes that occurred at night.

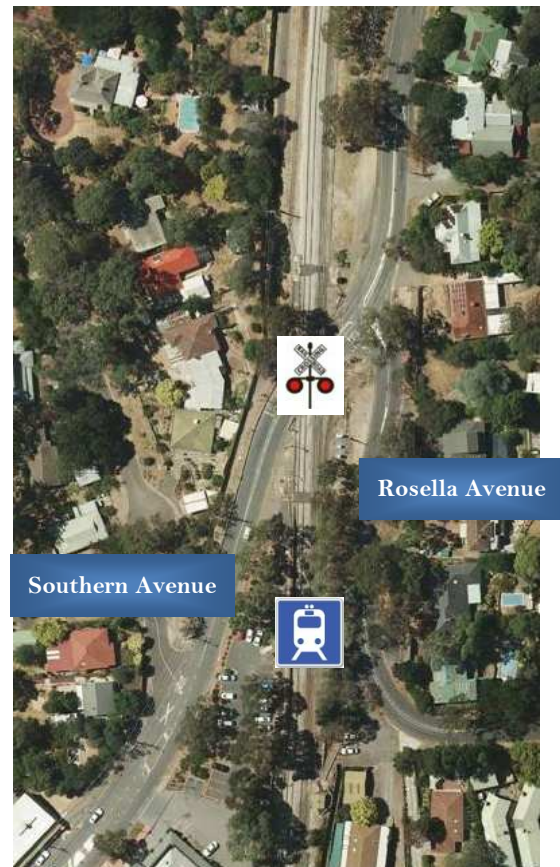
Figure 7.2.2.1 - Aerial Image of Mid-block (2012)

Guard fence lines the western side of Main Road from Southern Avenue to the level crossing and similarly a short section of guard fence lines the eastern side between the level crossing and Rosella Avenue. Hazard boards and advanced warning signage is provided on both approaches to the level crossing to warn and advise motorists they are approaching a level crossing and guide motorists through the bends in the road.

The Glenalta railway station is located to the east of Main Road as well as a parking facility for patrons accessing the train.

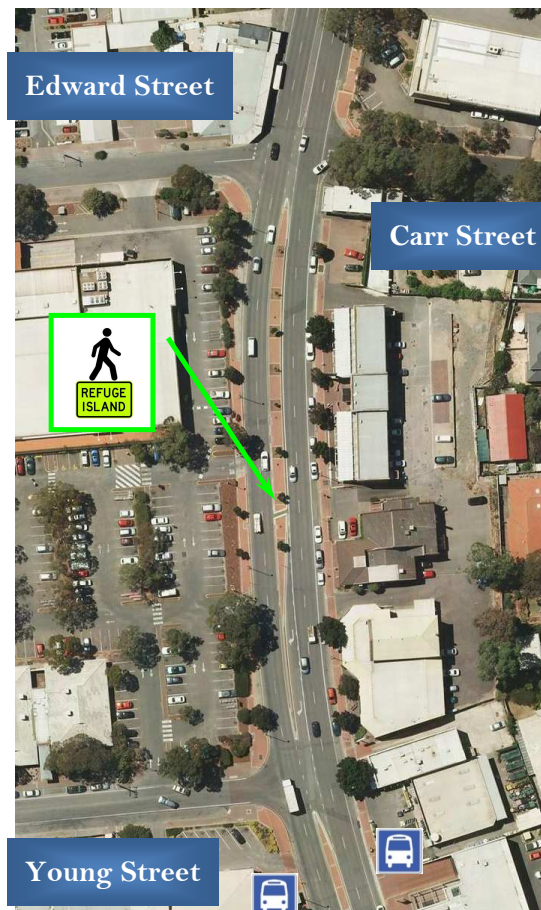
Figure 7.2.4.1 - Aerial Image of Mid-block (2012)

The speed limit along this section of Main Road was reduced from 60kph to 50kph in 2007 as part of a corridor speed reduction initiative between Burfield Street (50 metres south of) and Blackwood Roundabout.

Detailed analysis of the crash data indicates that factors contributing to crashes include the traffic and pedestrian movements generated by the surrounding land use, the conflict between slow moving and turning traffic and high volumes of through traffic, poor visibility around the sweeping bend, poorly designed accesses to off-street car parking and vehicles parking along the eastern side of Main Road. All of the reported crashes, except one of the hit fixed object crashes, occurred during weekday business hours. The other hit fixed object crash reported along this mid-block occurred late at night. Further analysis of incident reports indicate that all of the side swipe crashes were associated with southbound and northbound vehicles changing lane.
